IN THE COMMONWEALTH COURT OF PENNSYLVANIA

No. 587 MD 2014

# Appendix C

## Photographs Admitted Into Evidence by Petitioners

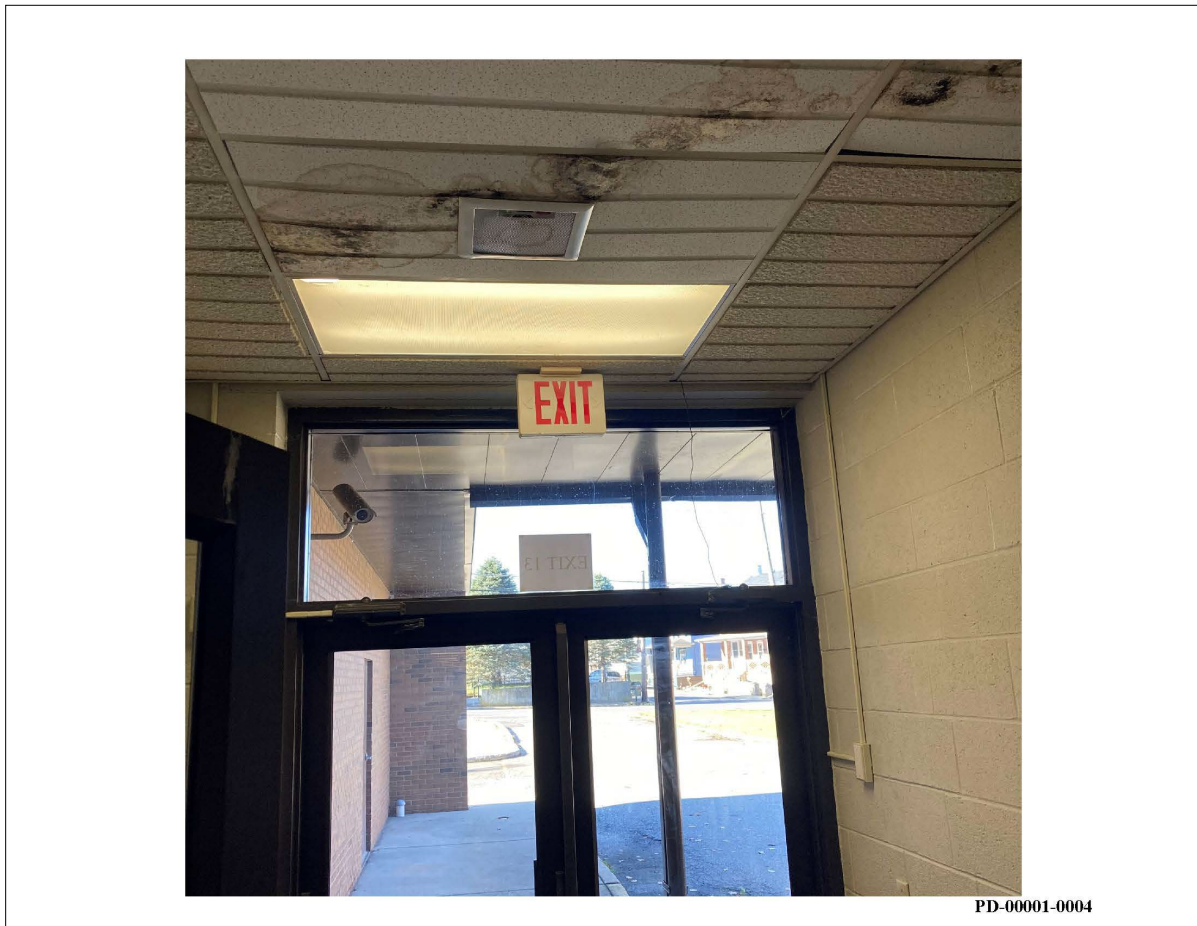
**PD-1-04** depicts a typical hallway in Panther Valley School District's elementary school. Tr. 788:18-789:3 (McAndrew). This hallway ceiling is stained with water damage caused by a roof leak, which caused Panther Valley to frequently test for mold. *Id.* This accurately depicts a typical Panther Valley elementary school hallway today. Tr. 788:22-23 (McAndrew).

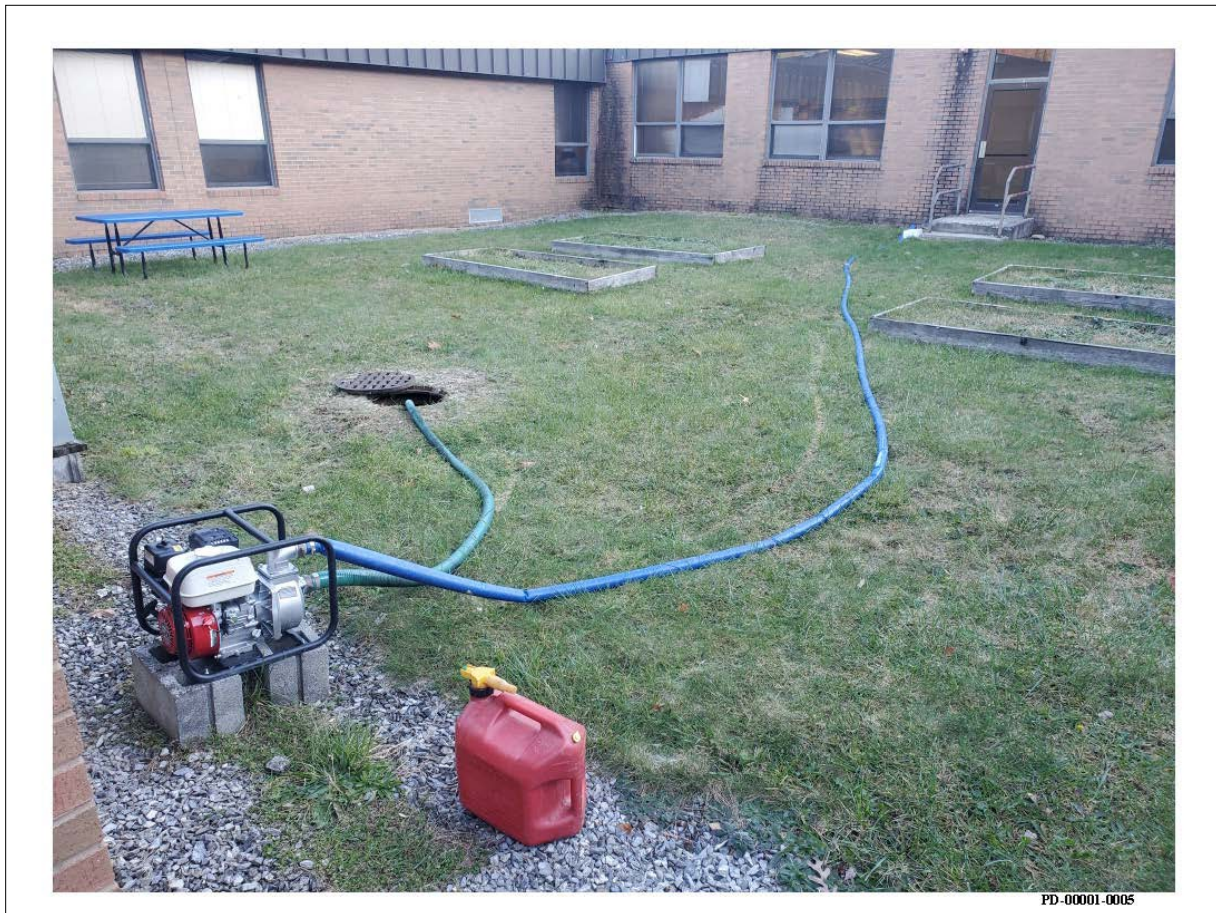
**PD-1-05** depicts the pump system outside of Panther Valley School District's elementary school, which is used to prevent rainwater from seeping in and flooding classrooms when it rains. Tr. 789:6-790:3 (McAndrew). This accurately depicts the condition at Panther Valley School District's elementary school today. Tr. 789:16-19 (McAndrew).

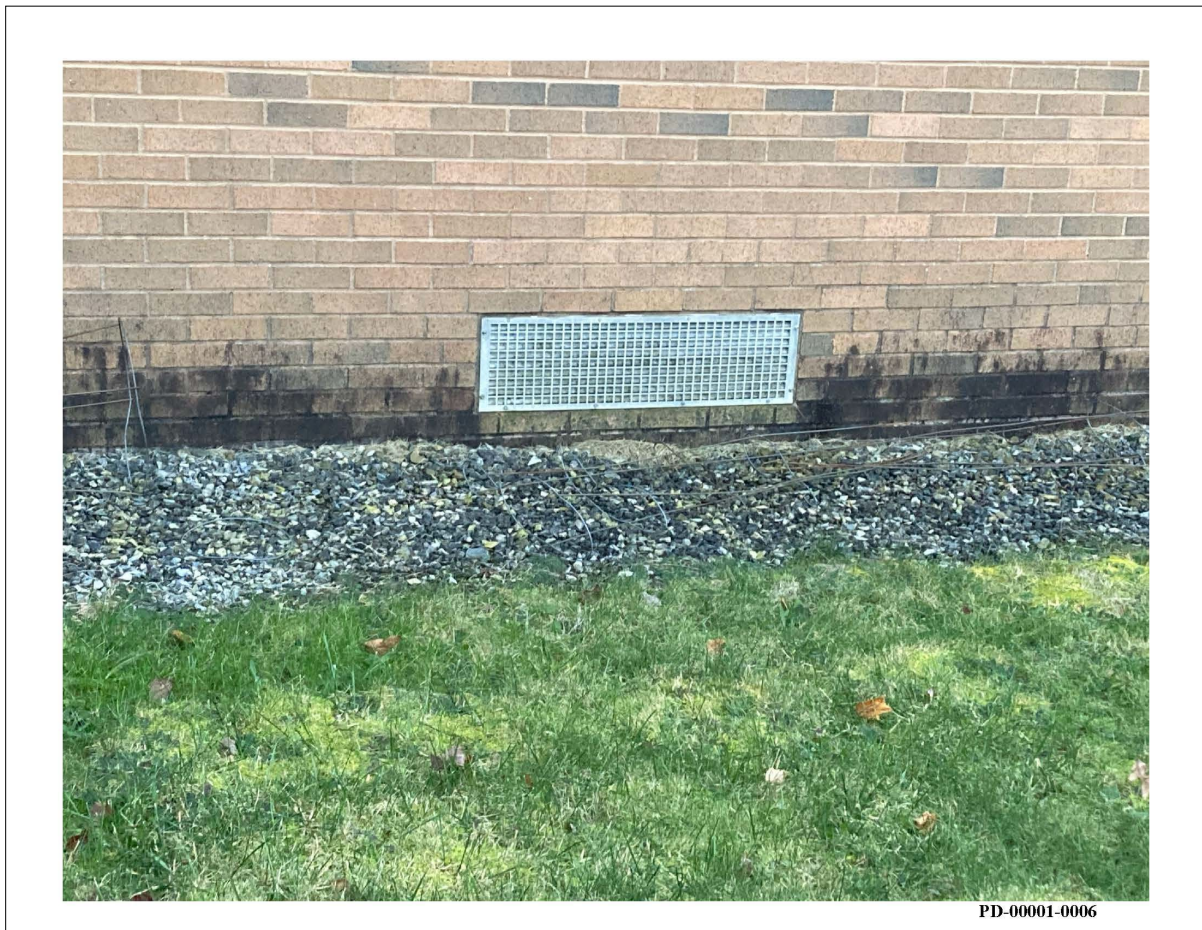
**PD-1-06** depicts the outside of the Panther Valley School District elementary school building, which is coated with mold. Tr. 790:7-19 (McAndrew). This image also shows broken screens lying alongside the building, as well as the poor drainage system adjacent to the building. Tr. 790:14-19 (McAndrew). This accurately depicts the condition outside of Panther Valley School District's elementary school today. Tr. 790:20-23 (McAndrew).

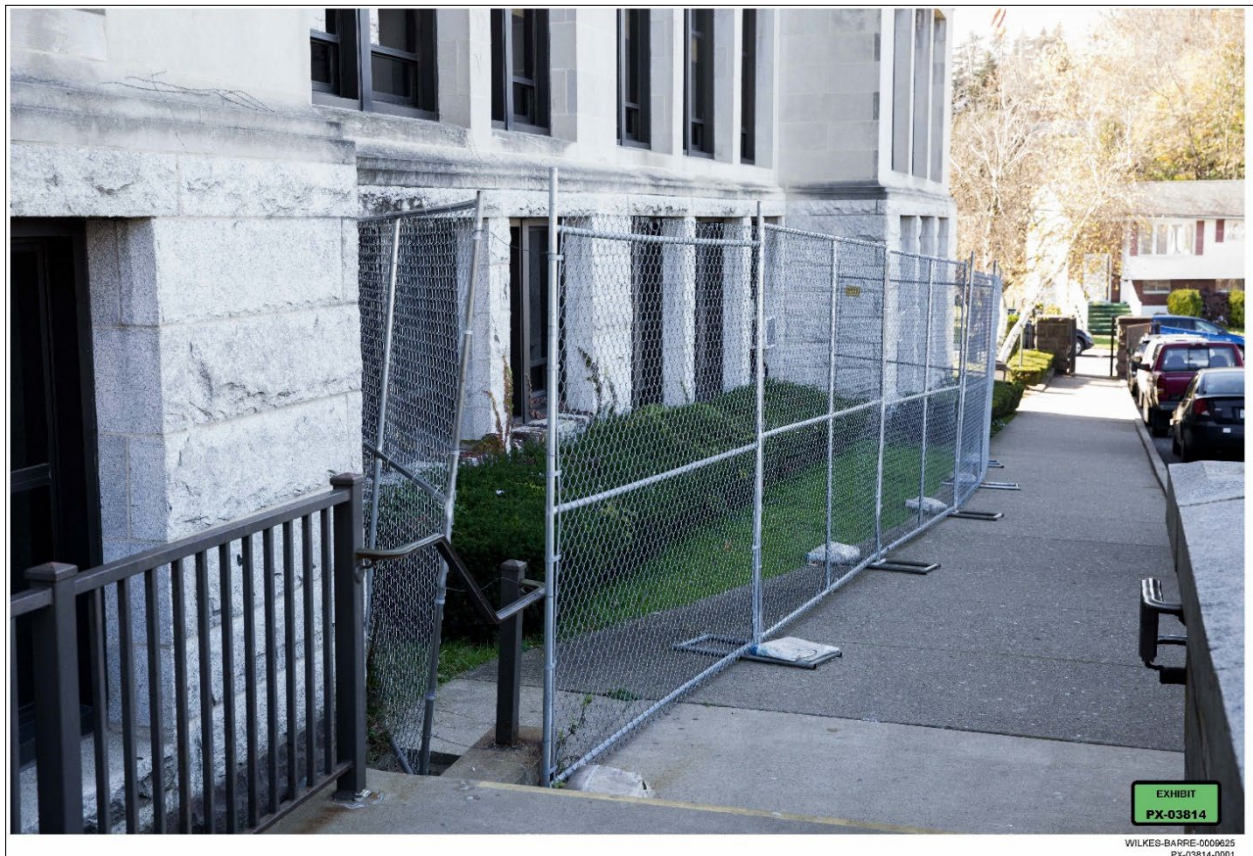
EXHIBIT  
PX-03814

**PX-3814** depicts the front walkway outside of GAR Middle School in Wilkes-Barre Area School District, which is shielded by protective fencing to prevent falling debris from the building's decaying parapet from injuring students and pedestrians. Tr. 10814:24-10815:15 (Costello). This accurately depicts current conditions at GAR Middle School. Tr. 10821:11-15 (Costello).

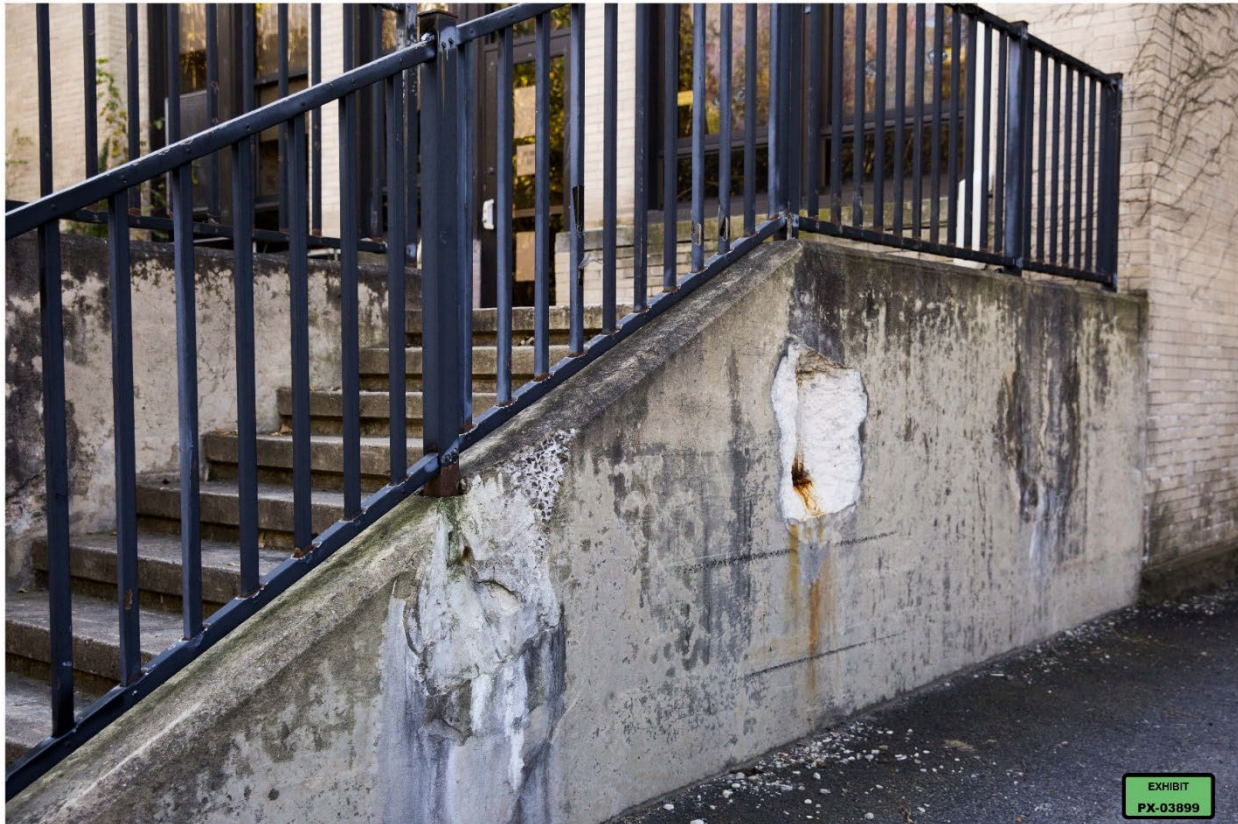
WILKES-BARRE-0006710  
PX-03899-0001

**PX-3899** depicts steps outside of GAR Middle School in Wilkes-Barre Area School District, which are crumbling and which has steel delaminating. Tr. 10818:13-10819:2 (Costello). The district has been unable to repair these conditions due to a lack of funds. Tr. 10818:17-10819:2 (Costello).

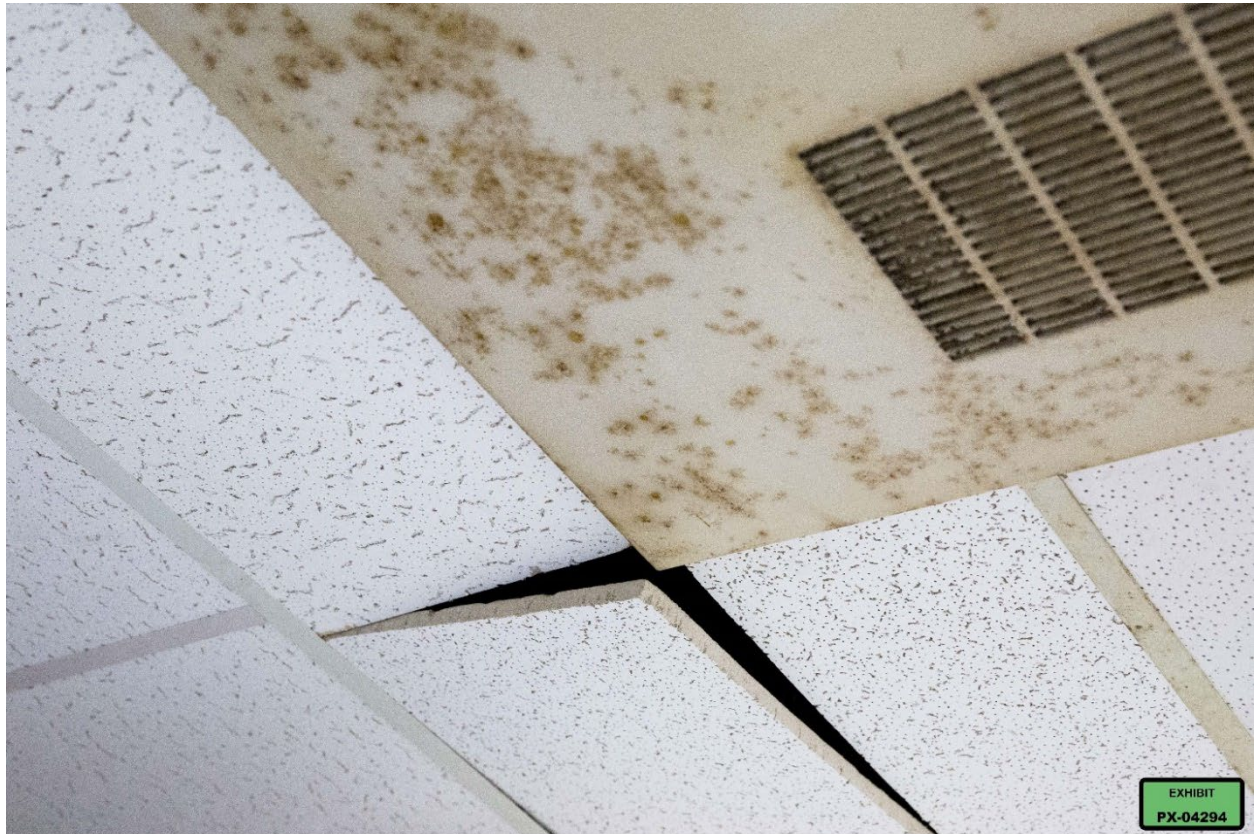
EXHIBIT  
**PX-04294**

**PX-4294** depicts the dirty, rusted ceiling vent and falling ceiling tiles in a classroom at Walnut Elementary in William Penn School District. Tr. 7013:18-7014:8 (Harbert) The conditions of these vents affect the already poor ventilation conditions in Walnut Elementary. Tr. 7014:3-8 (Harbert).
