IN THE COMMONWEALTH COURT OF PENNSYLVANIA

No. 587 MD 2014

# Appendix C

## Photographs Admitted Into Evidence by Petitioners

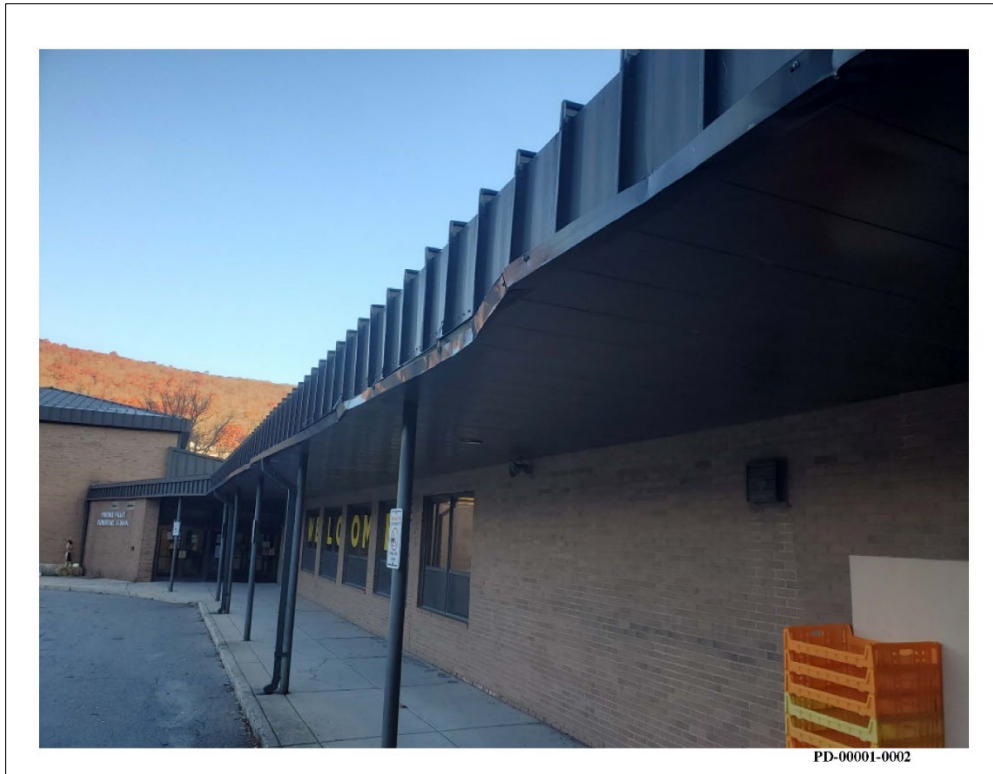
**PD-1-02** depicts the front of Panther Valley School District's elementary school, where the façade and roof have degraded. Tr. 785:23-786:10 (McAndrew). This accurately depicts what the Panther Valley School District's elementary school looks like today. Tr. 786:1-4 (McAndrew).

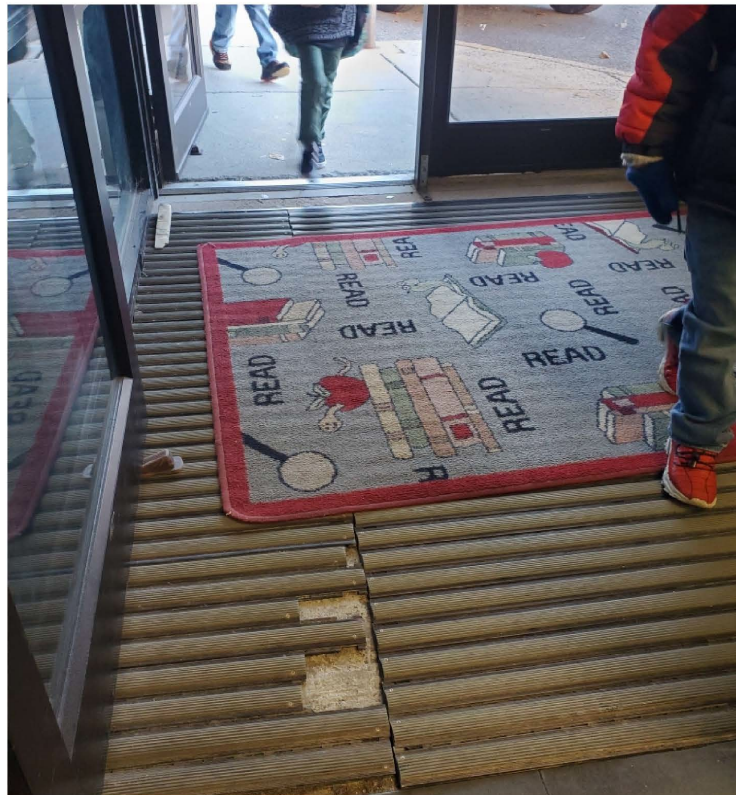
**PD-1-03** depicts the front entrance of Panther Valley School District's elementary school, where the floor has worn and ripped over time to create a tripping hazard.

Tr. 786:13-24 (McAndrew). This accurately depicts the conditions at Panther Valley School District's elementary school today. Tr. 787:1-4 (McAndrew).

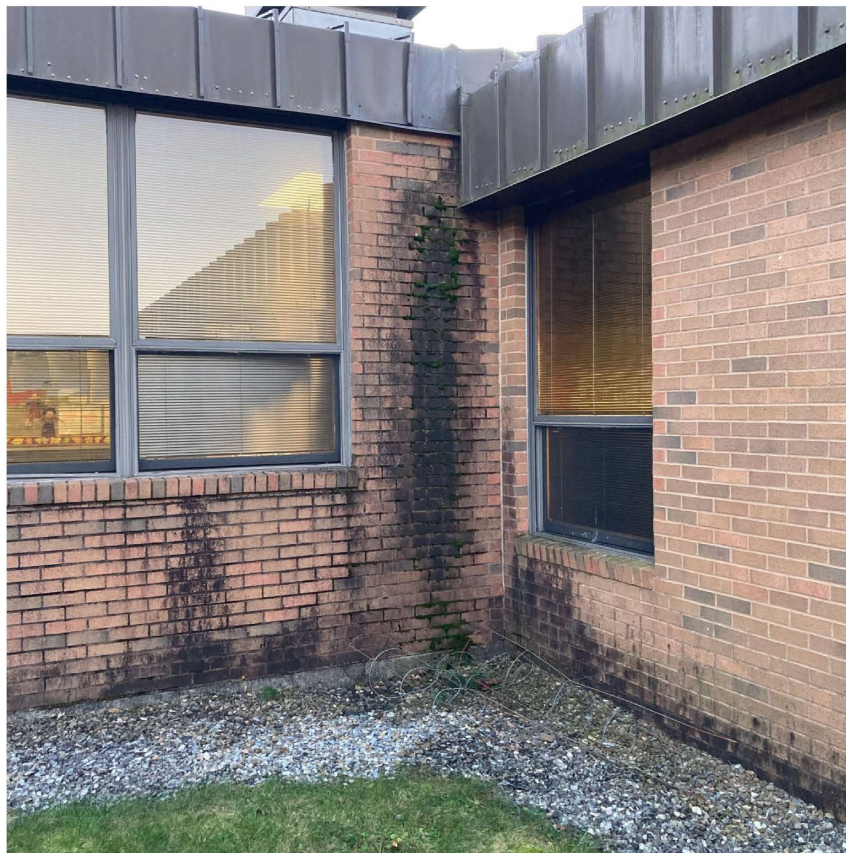
**PD-1-07** depicts an outside wall of Panther Valley School District elementary school, which is coated in mold. Tr. 791:2-13 (McAndrew). This accurately depicts the condition outside of Panther Valley School District's elementary school today. Tr. 791:14-17 (McAndrew).

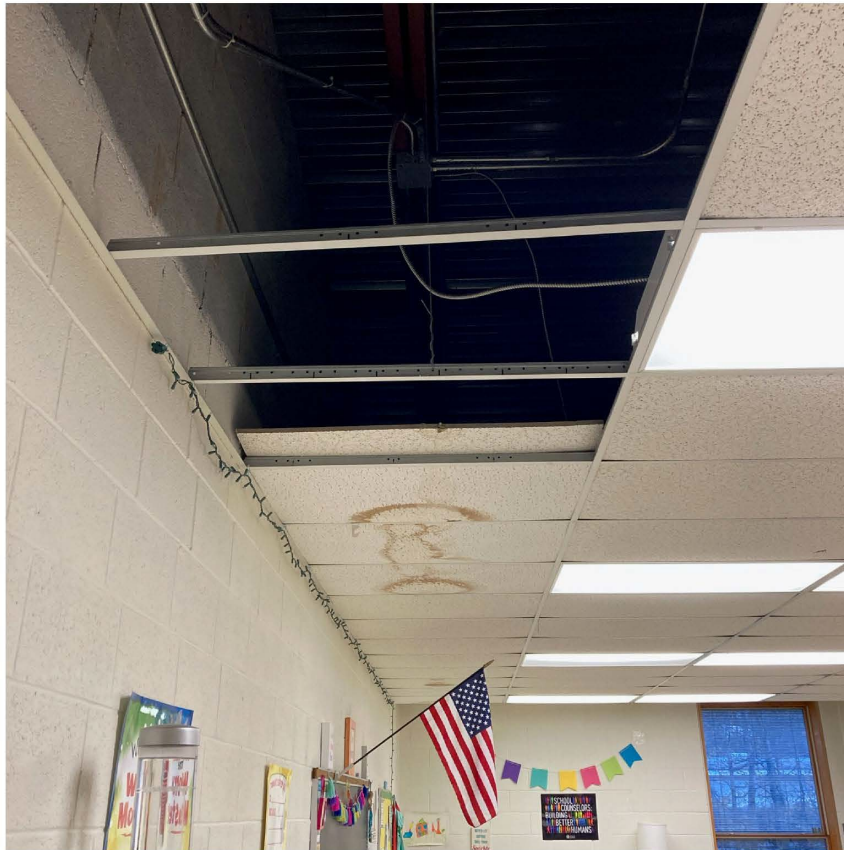
**PD-1-08** depicts an open ceiling, which has lost damaged ceiling tiles and is stained by water, at Panther Valley School District's elementary school. Tr. 791:20-792:4 (McAndrew). This accurately depicts the typical conditions of the ceilings at Panther Valley School District's elementary school today. Tr. 792:5-8 (McAndrew).

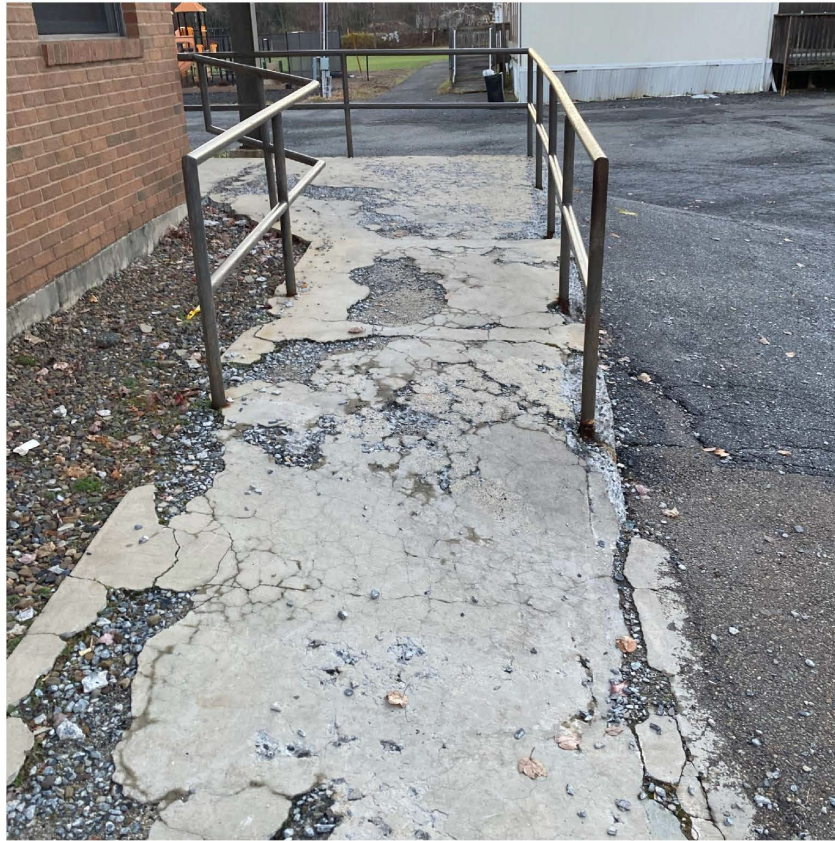
**PD-1-09** depicts the handicap ramp outside of Panther Valley School District's elementary school, which is deteriorated and crumbling. Tr. 792:11-20 (McAndrew). This is an accurate representation of the of the ramp at Panther Valley School District today. Tr. 792:21-24 (McAndrew).

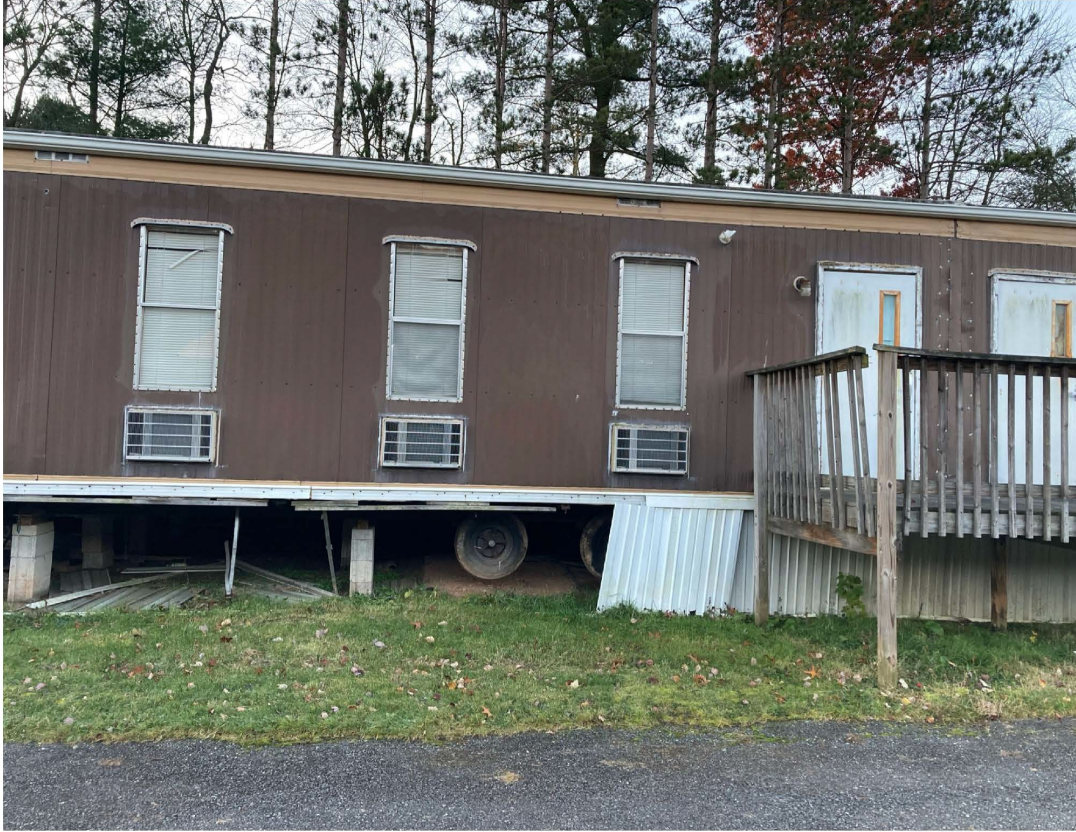
**PD-1-10** depicts the trailers at Panther Valley School District's elementary school. Tr. 793:4-10 (McAndrew). This is an accurate representation of the conditions at Panther Valley elementary school. Tr. 793:11-14 (McAndrew).

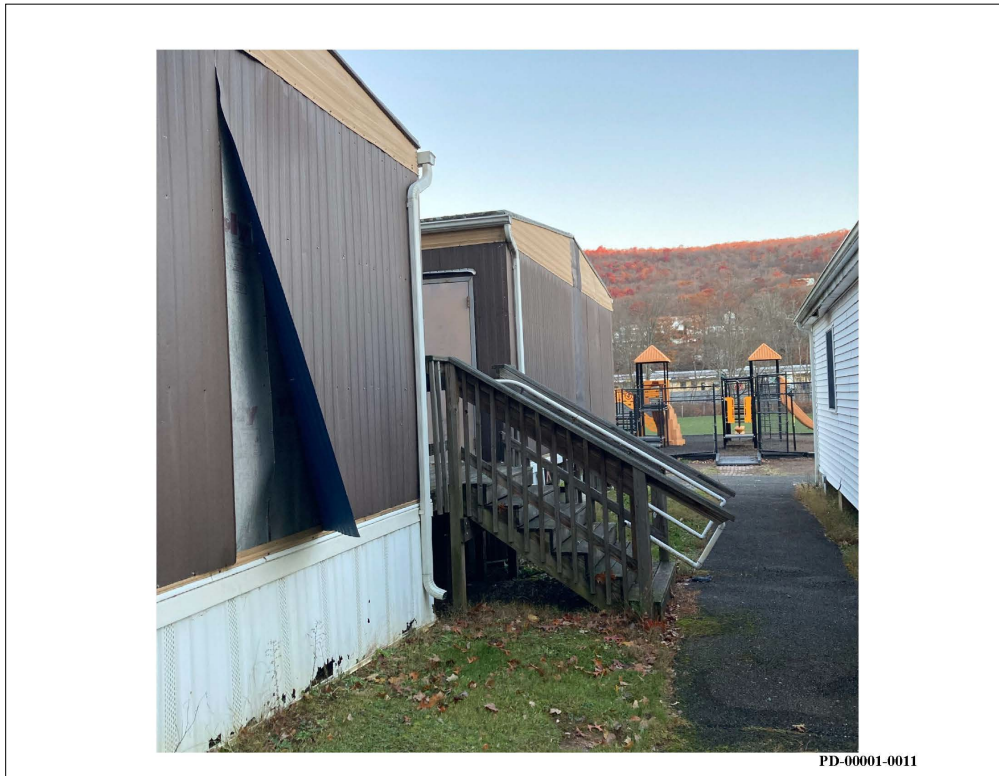
**PD-1-11** depicts additional deteriorating trailers at Panther Valley School District's elementary school. Tr. 793:18-794:3 (McAndrew). The picture also depicts the playground in the background, which Panther Valley School District funded with community resources and grants. Tr. 793:24-794:3 (McAndrew). This is an accurate representation of the conditions at Panther Valley School District elementary school. Tr. 793:11-14 (McAndrew).

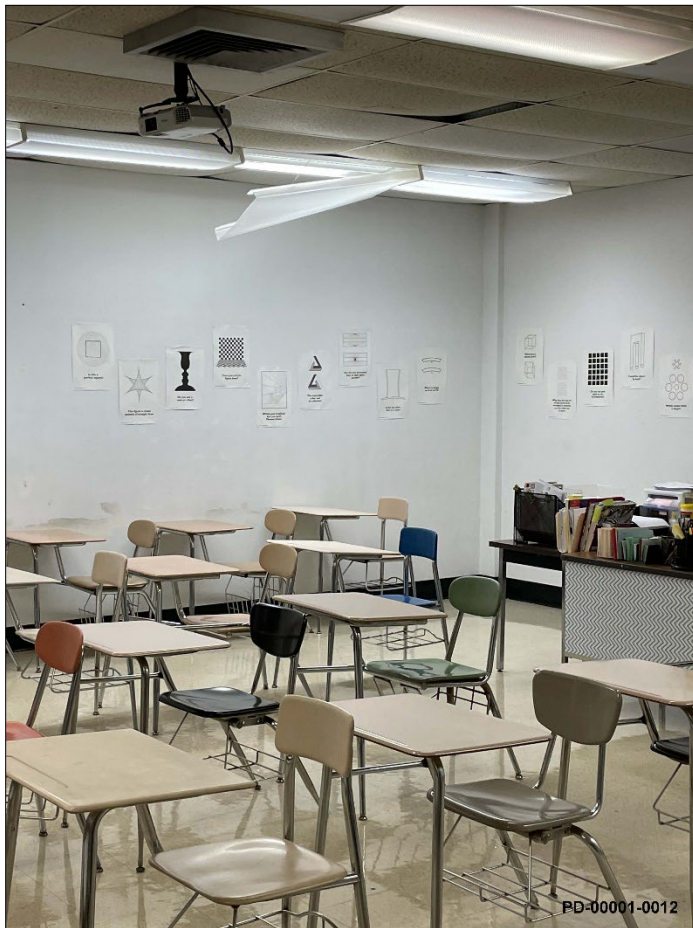
**PD-1-12** depicts a high school classroom, with a partially detached light fixture and partially exposed ceiling, in Panther Valley School District's junior-senior high school. Tr. 794:8-20 (McAndrew). This classroom is an accurate representation of the typical classroom for 9th through 12th graders at Panther Valley School District today. Tr. 794:15-20 (McAndrew).

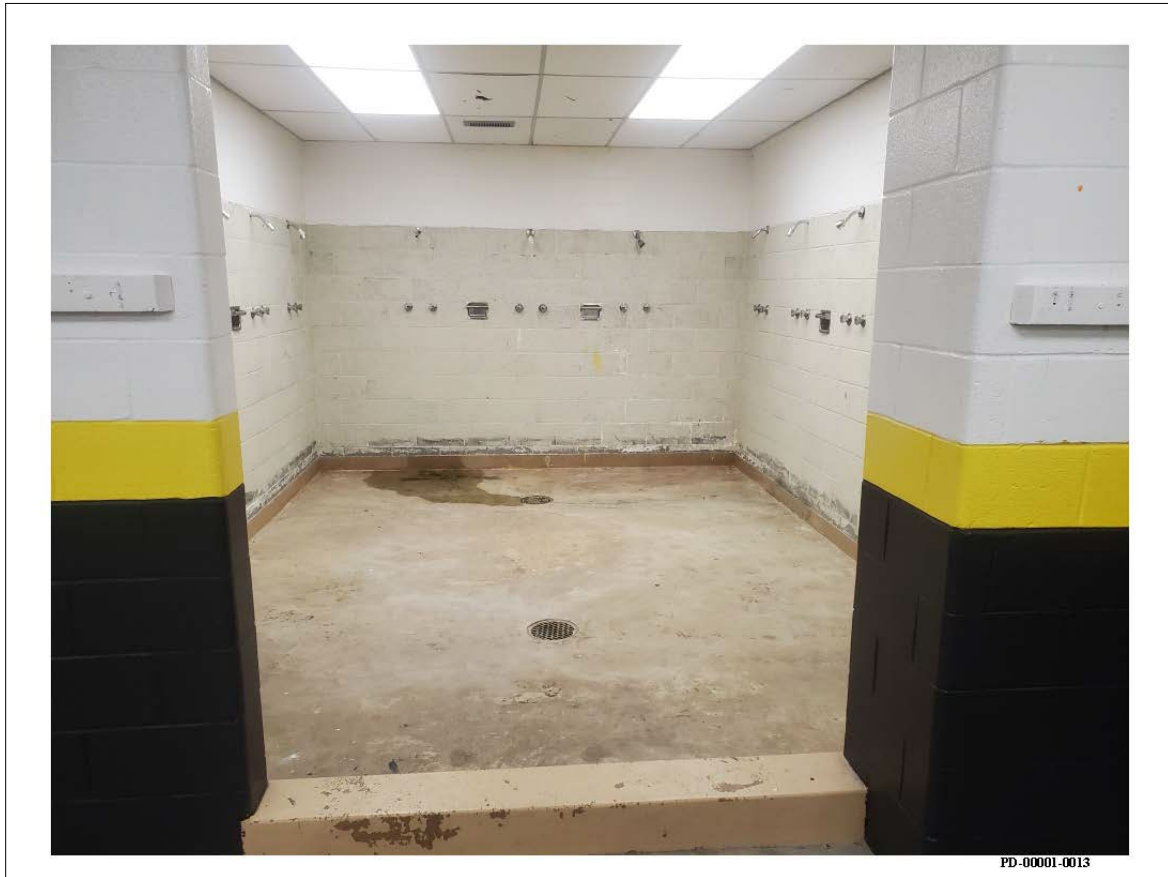
**PD-1-13** depicts the high school shower area at Panther Valley School District. Tr. 794:21-795:2 (McAndrew) These showers are no longer functional. Tr. 795:1-2 (McAndrew). This is an accurate representation of the high school showers at Panther Valley today School District. Tr. 795:3-5 (McAndrew).

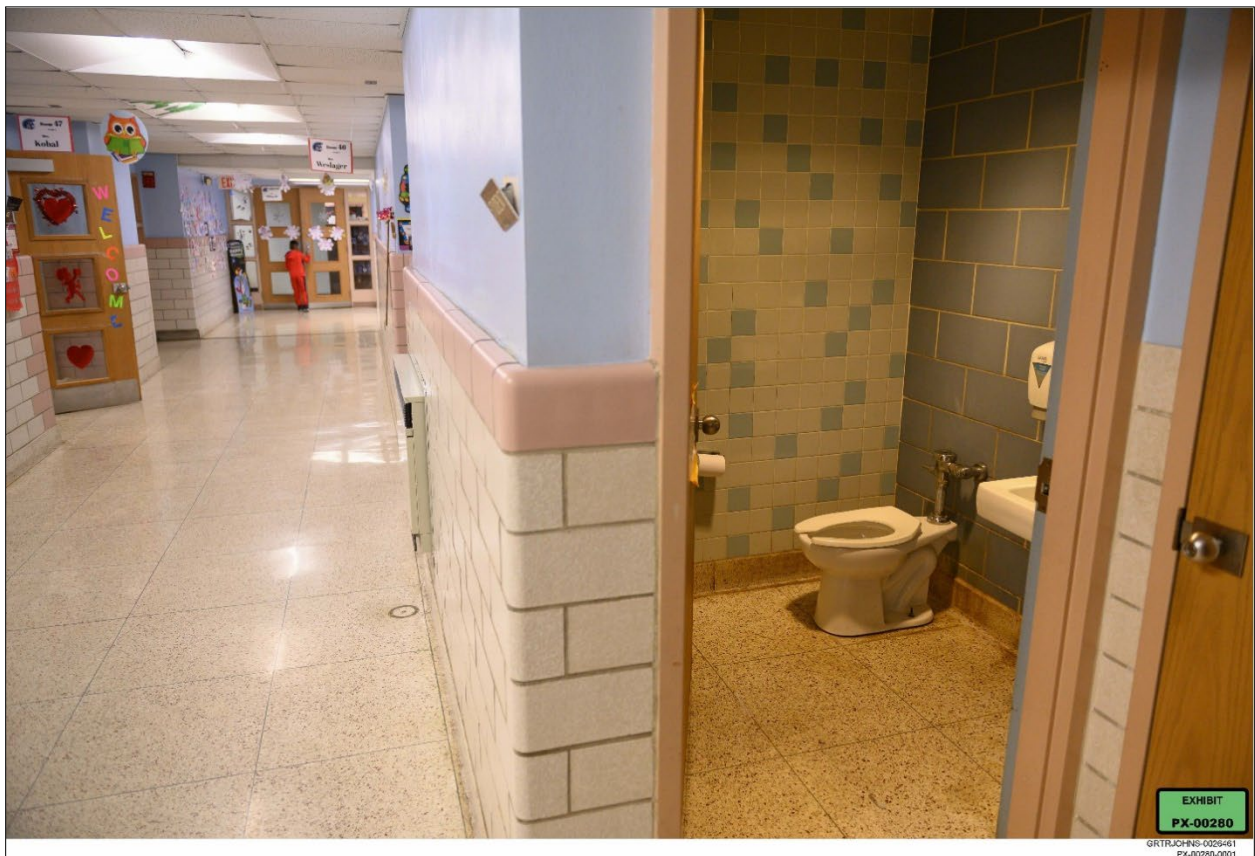
**PX-280** depicts a single-toilet bathroom in the elementary school at Greater Johnstown School District. Tr. 3303:17-Tr. 3304:24 (Kobal). This toilet serves 125 first-graders elementary students and is the only restroom on the floor. Tr. 3303:20-Tr. 3304:3 (Kobal). Because this is the only facility, students have occasionally have accidents in the hallway due to long lines and the restroom regularly becomes “disgusting” by early afternoon due to students’ inability to properly use the restroom properly. Tr. 3305:9-3306:21 (Kobal). This photo depicts the current conditions of the school. Tr. 3304:14-16 (Kobal).

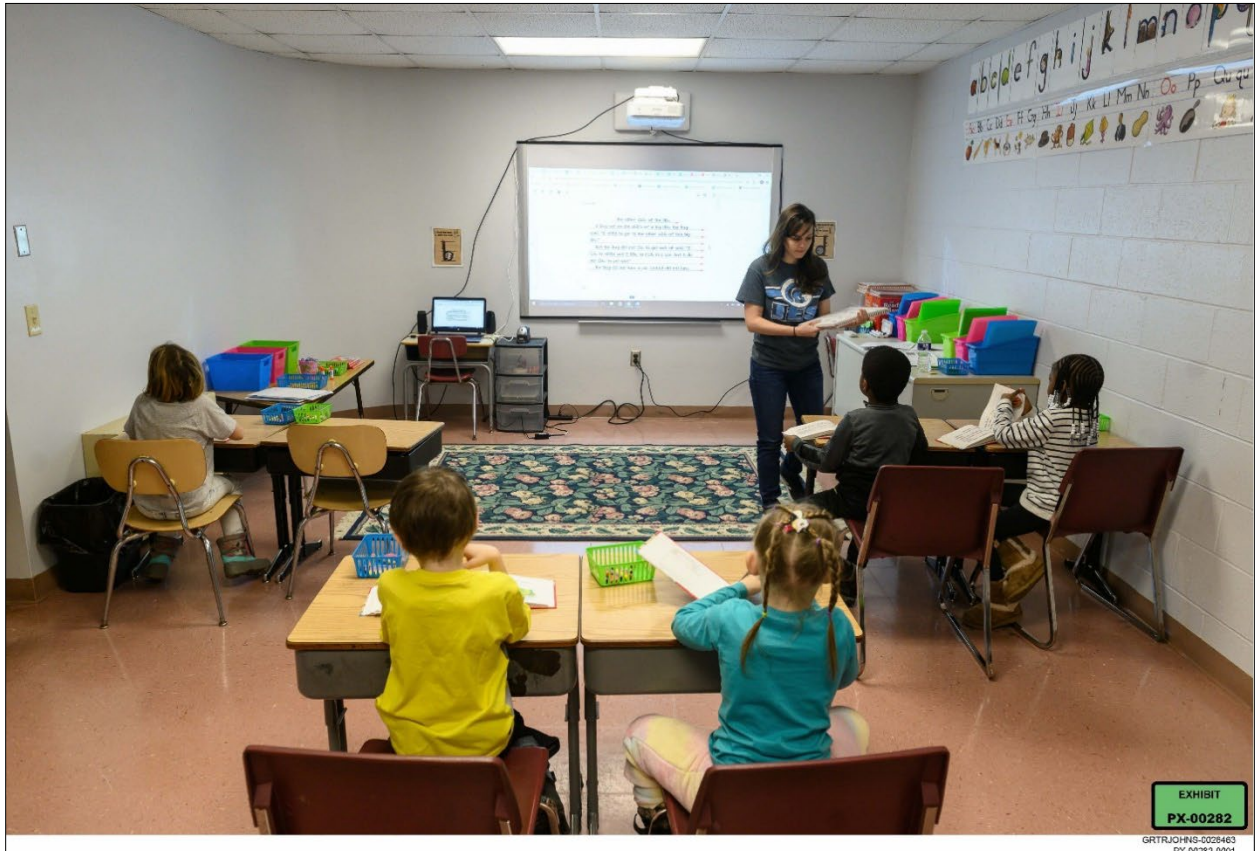
**PX-282** depicts students learning in a cinderblock storage room without windows or ventilation, which has been converted into a classroom in Greater Johnstown School District. Tr. 2648:20-2651:22 (Arcurio). This photo depicts the conditions of the elementary school as students learn. Tr. 2650:23-2651:4 (Arcurio).

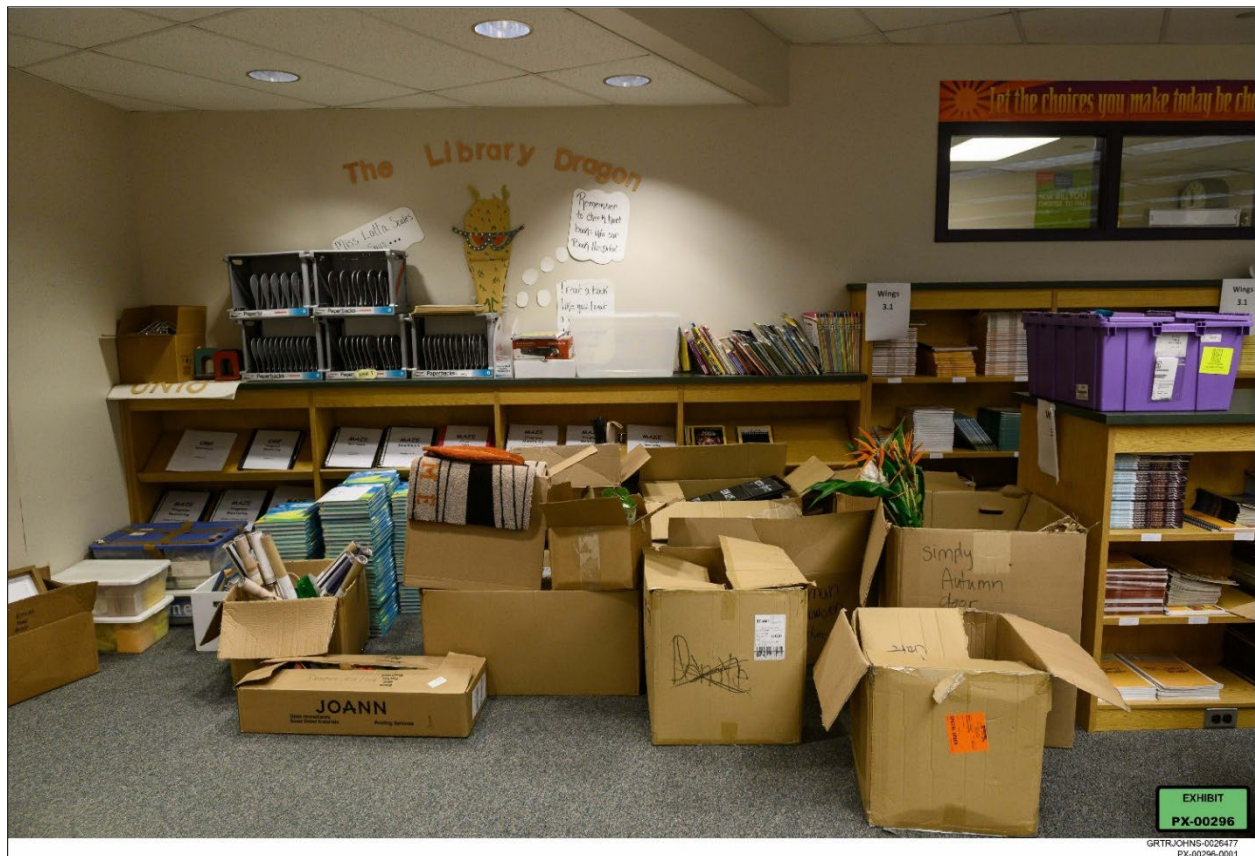
**PX-296** depicts a library at Greater Johnstown School District middle school that was repurposed as a storage area. Tr. 2682:2-11 (Arcurio). The district decided to utilize Greater Johnstown School District's part-time librarian as a reading teacher and cannot afford to hire additional librarians. Tr. 2683:11-2684:9 (Arcurio). Because the school is repurposed from an elementary school to a middle school, the individual classrooms require more space for seating older students; teachers have had to rely on alternative storage places, like this library, for their classroom materials. Tr. 2684:18-2685:16 (Arcurio).

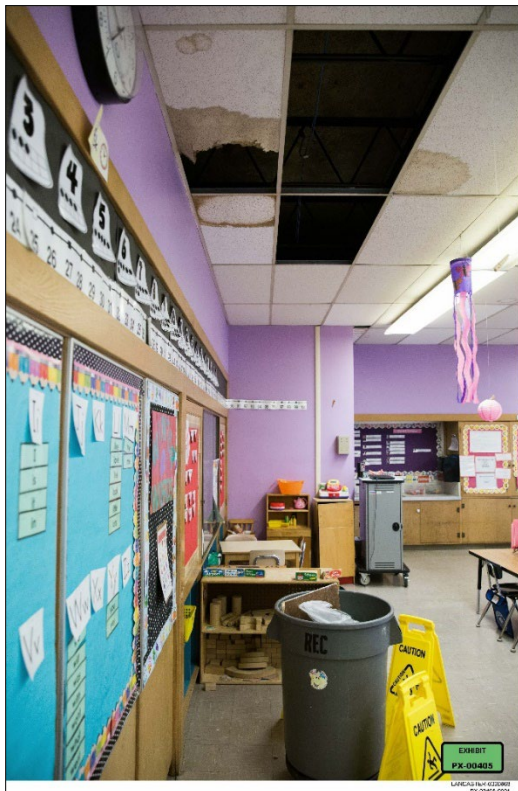
**PX-405** depicts a classroom ceiling, which is stained brown and deteriorated from long-term water damage caused by a roof leak, at Hamilton Elementary School in the School District of Lancaster. Tr. 5796:18-5797:18 (Przywara). This image also depicts trashcans on the floor to collect water dripping into the classroom as a result of roof leaks and ceiling damage. Tr. 5797:9-18 (Przywara). Because there were no additional spaces in the building, students would learn in the classroom as water dripped through the roof. Tr. 5796:20-5796:18 (Przywara). The roof at Hamilton has been repaired since the time of this photo, but this is representative of the recurring concerns in Hamilton and other schools in Lancaster. Tr. 5797:22-5798:8 (Przywara).

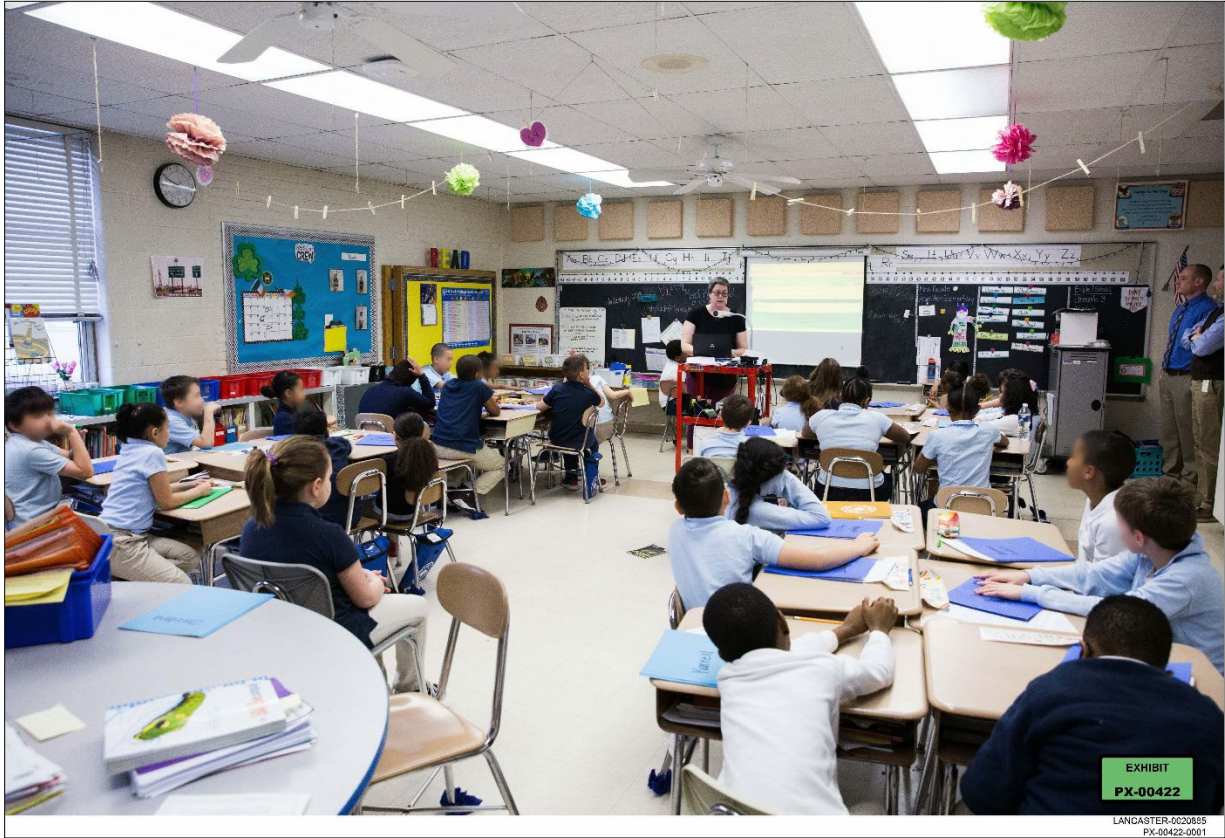
PX-422 depicts a 3rd grade classroom with 28 students at Hamilton Elementary School in the School District of Lancaster. Tr. 5798:11-5799:3 (Przywara). This image accurately represents the typical classroom in Hamilton Elementary School, which currently has over an average class size ratio of 25 students to 1 teacher. Tr. 5799:4-9 (Przywara).

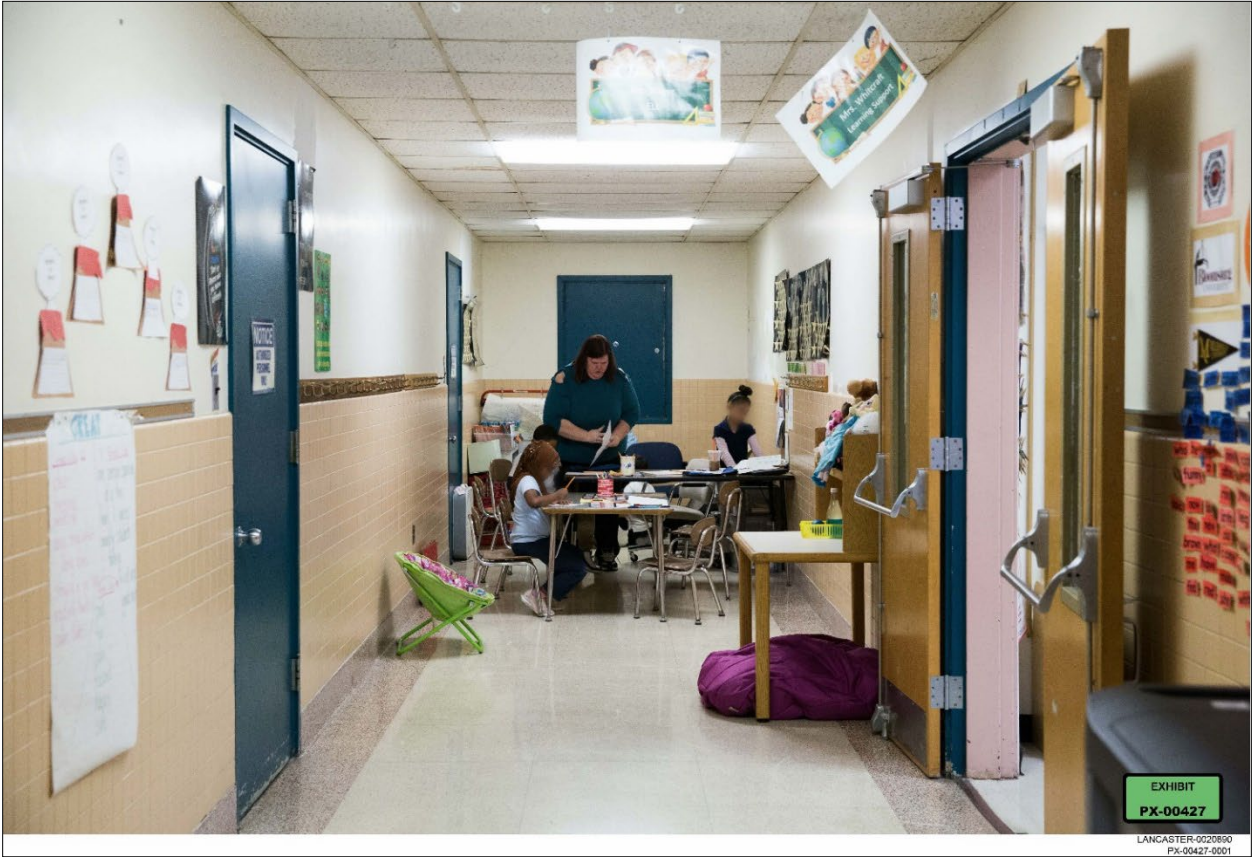
**PX-427** depicts a teacher educating students in a hallway at Hamilton Elementary School in the School District of Lancaster. Tr. 5779:12-5800:12 (Przywara). This teacher permanently provides instruction to students in the hallway for the full school year. Tr. 5800:1-12 (Przywara). Teachers continue to use hallways as learning spaces today. Tr. 5800:13-5801:2 (Przywara).

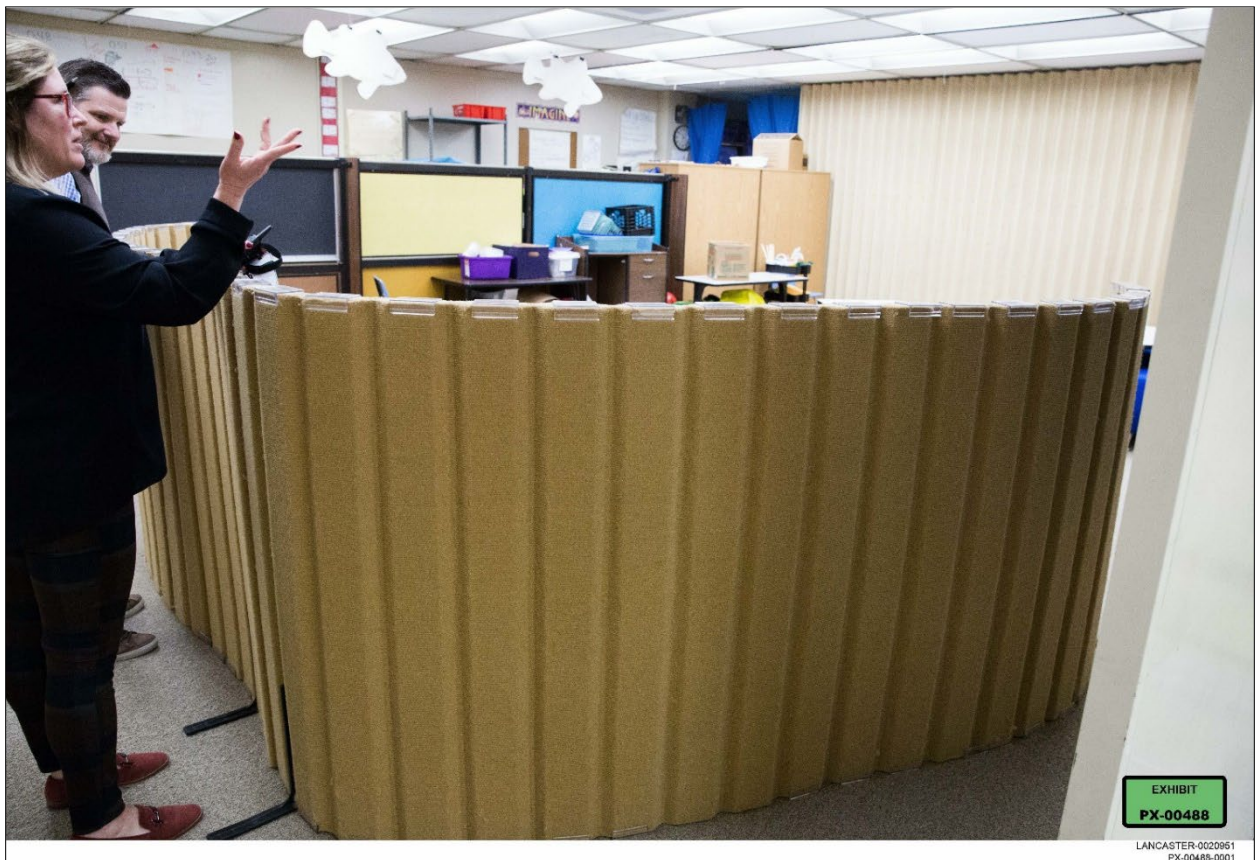
**PX-488** depicts the open concept classroom in Price Elementary School in the School District of Lancaster, which has classrooms created out of dividers instead of walls. Tr. 5802:3-5803:13 (Przywara). In this image, one classroom of students is behind the shorter divider and another classroom of students is behind the two adults standing in the “hallway.” Tr. 5802:5-5803:13 (Przywara). The full-length “curtain wall” was installed in the 1970s, one of many in the school, many of which are non-functional. Tr. 5802:22-5803:5 (Przywara). This photo depicts the current conditions at Price Elementary School. Tr. 5803:14-17 (Przywara).

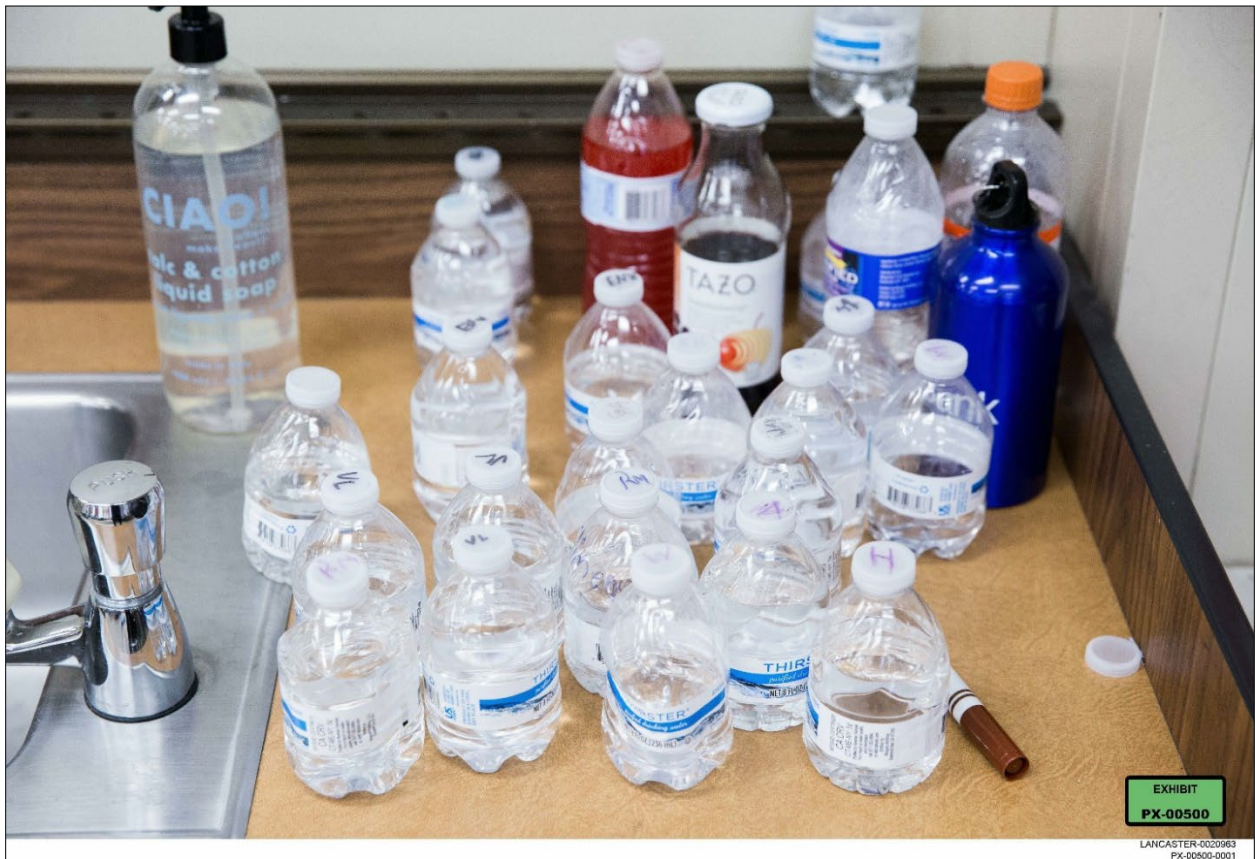
**PX-500** depicts water bottles that Price Elementary School in the School District of Lancaster had to provide students after discovering that school pipes contaminated the drinking water with lead. Tr. 5803:20-5804:15 (Przywara). Price Elementary had to provide bottles to students every day for a year. Tr. 5804:11-15 (Przywara). The school has temporarily fixed this problem by installing filters on the water fountains and more regularly testing for lead, but the pipes still exist in the school today. Tr. 5804:16-5805:16 (Przywara).

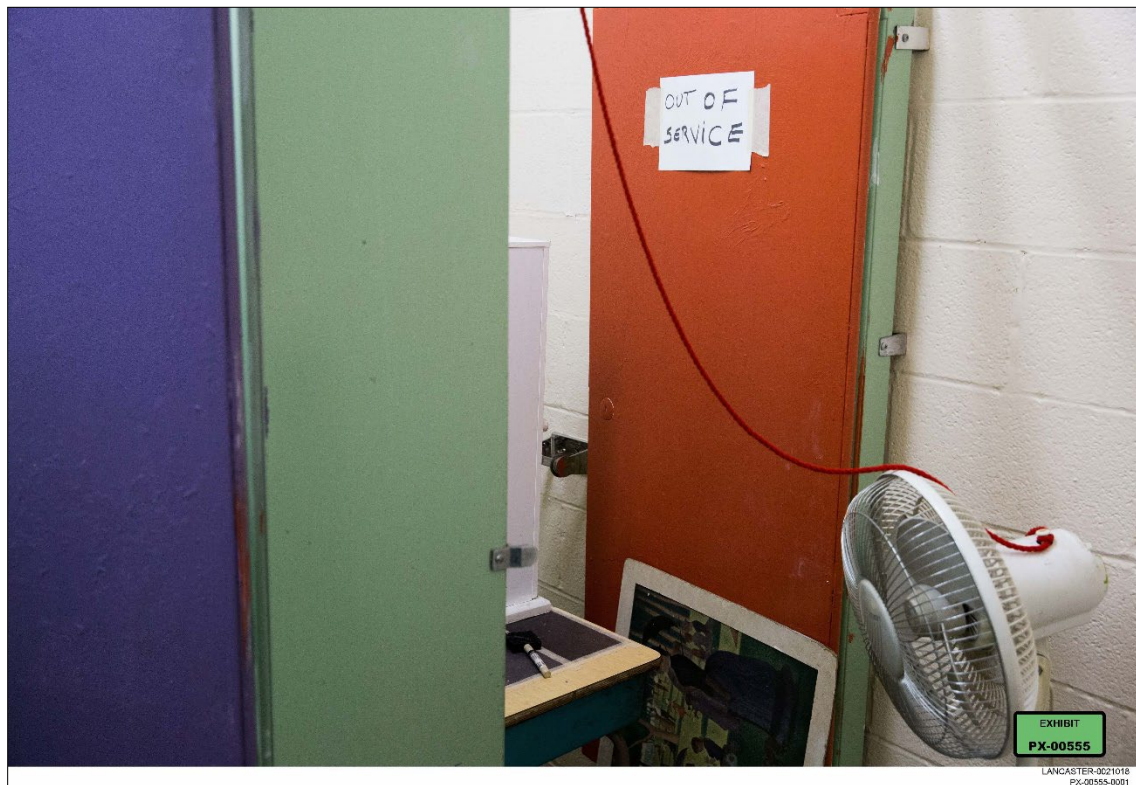
**PX-555** depicts restrooms at King Elementary in the School District of Lancaster, with one stall out of service and with a fan to compensate for a lack of ventilation. This is near the music room, which was constructed out of old locker rooms. Tr. 5794:23-5795:16 (Przywara). These conditions accurately reflect the restrooms at King Elementary today. Tr. 5795:15-17 (Przywara).

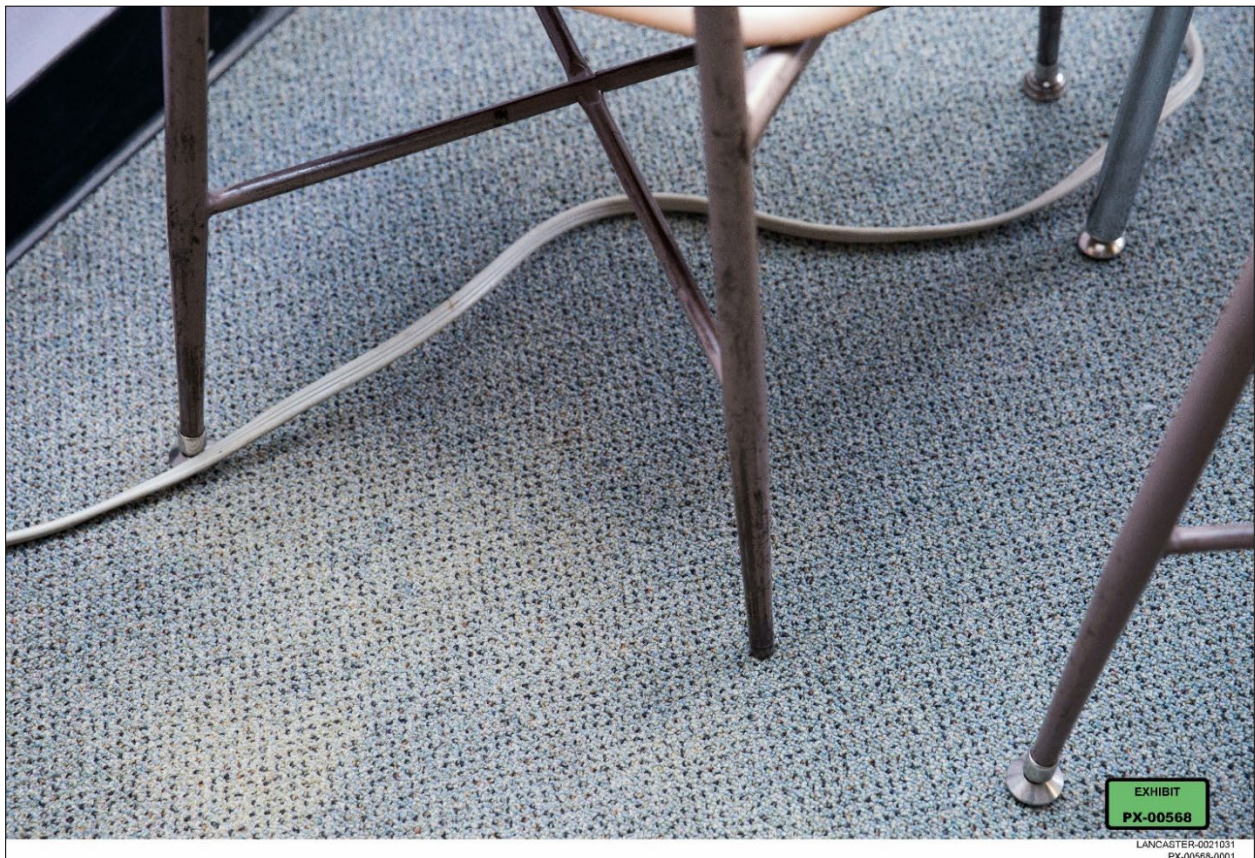
**PX-568** depicts a typical classroom at King Elementary School in the School District of Lancaster, with an extension cord running through the class and under student desks creating a tripping hazard. Tr. 6038:24-6039:10. (Aikens). This hazard exists in every classroom at King Elementary School. Tr. 6039:11-13 (Aikens). This is an accurate representation of King Elementary classrooms today. Tr. 61039:14-17 (Aikens).

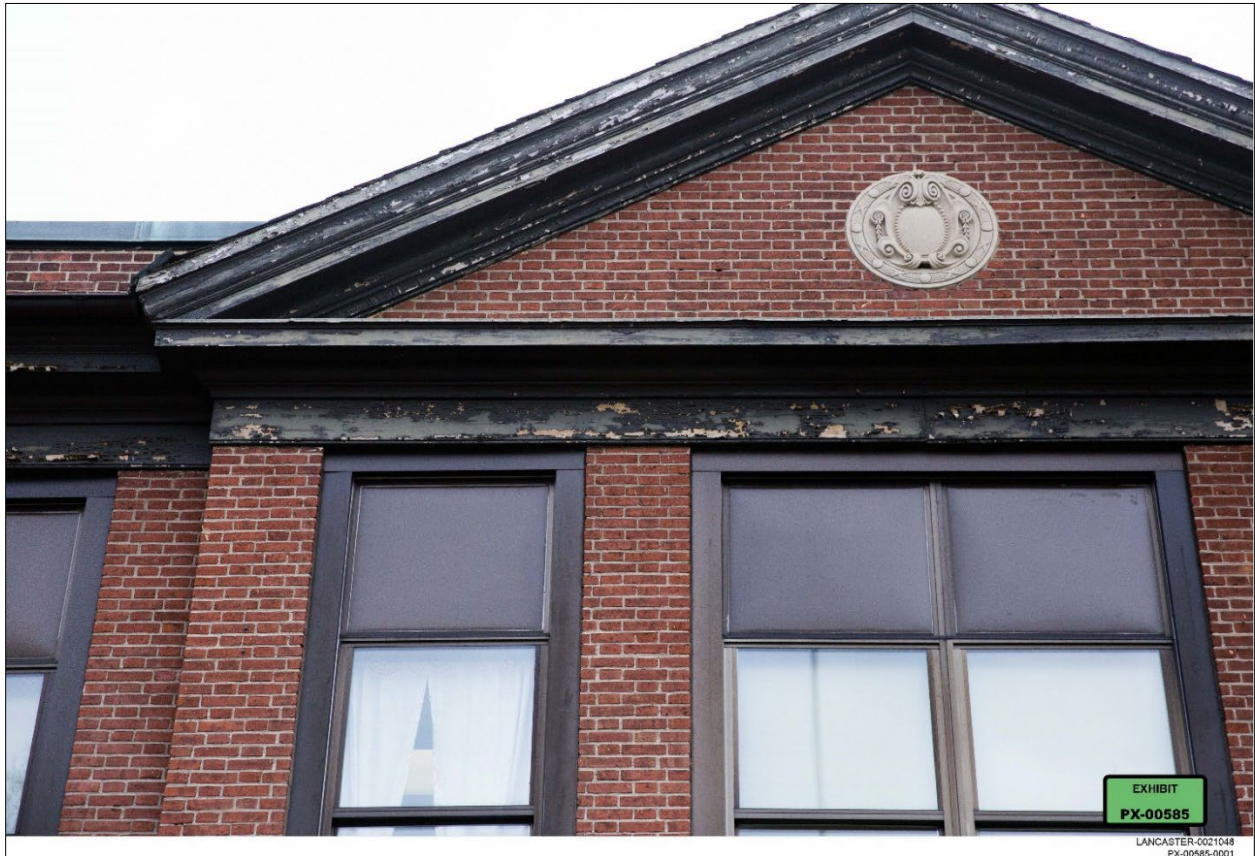
**PX-585** depicts the outside of Wickersham Elementary School in the School District of Lancaster, which has mold and peeling paint along the roofline. Tr. 5778:4-11 (Przywara). The state of Wickersham ultimately required the district to renovate the building. Tr. 5776:12-5777:6 (Przywara).

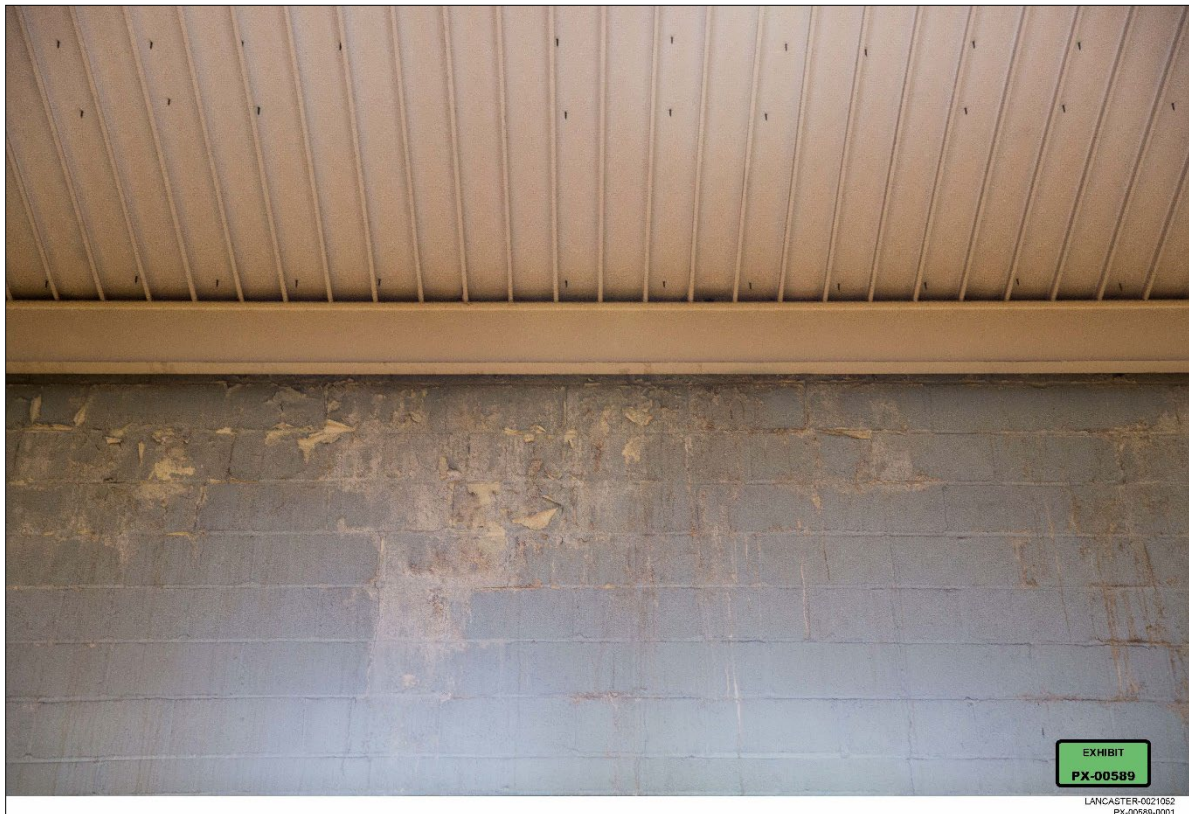
**PX-589** depicts the gymnasium at Wickersham Elementary School in the School District of Lancaster, which has moisture damage and peeling paint along the roofline as well as mildew coating the cement. Tr. 5778:17-5779:6 (Przywara). The state of Wickersham ultimately required the district to renovate the building. Tr. 5776:12-5777:6 (Przywara).

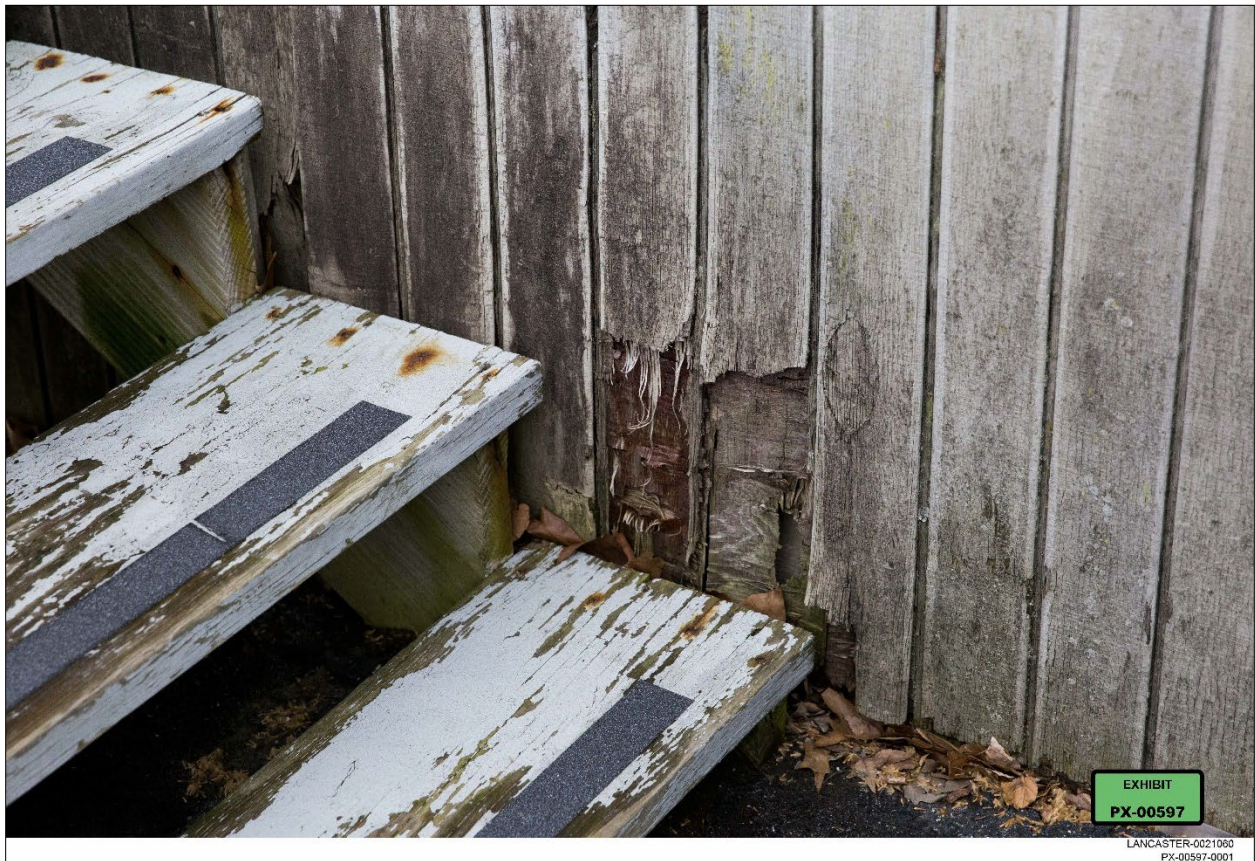
**PX-597** is a close-up depiction of the rotting, rust and mildew along the skirt of a classroom trailer outside of Wickersham Elementary in the School District of Lancaster. Tr. 5781:14-5782:14 (Przywara). Wickersham has since been renovated, but these trailers were typical and in use for several years prior to the renovations. Tr. 5781:17-5782:14 (Przywara).
