IN THE COMMONWEALTH COURT OF PENNSYLVANIA

No. 587 MD 2014

# Appendix C

## Photographs Admitted Into Evidence by Petitioners

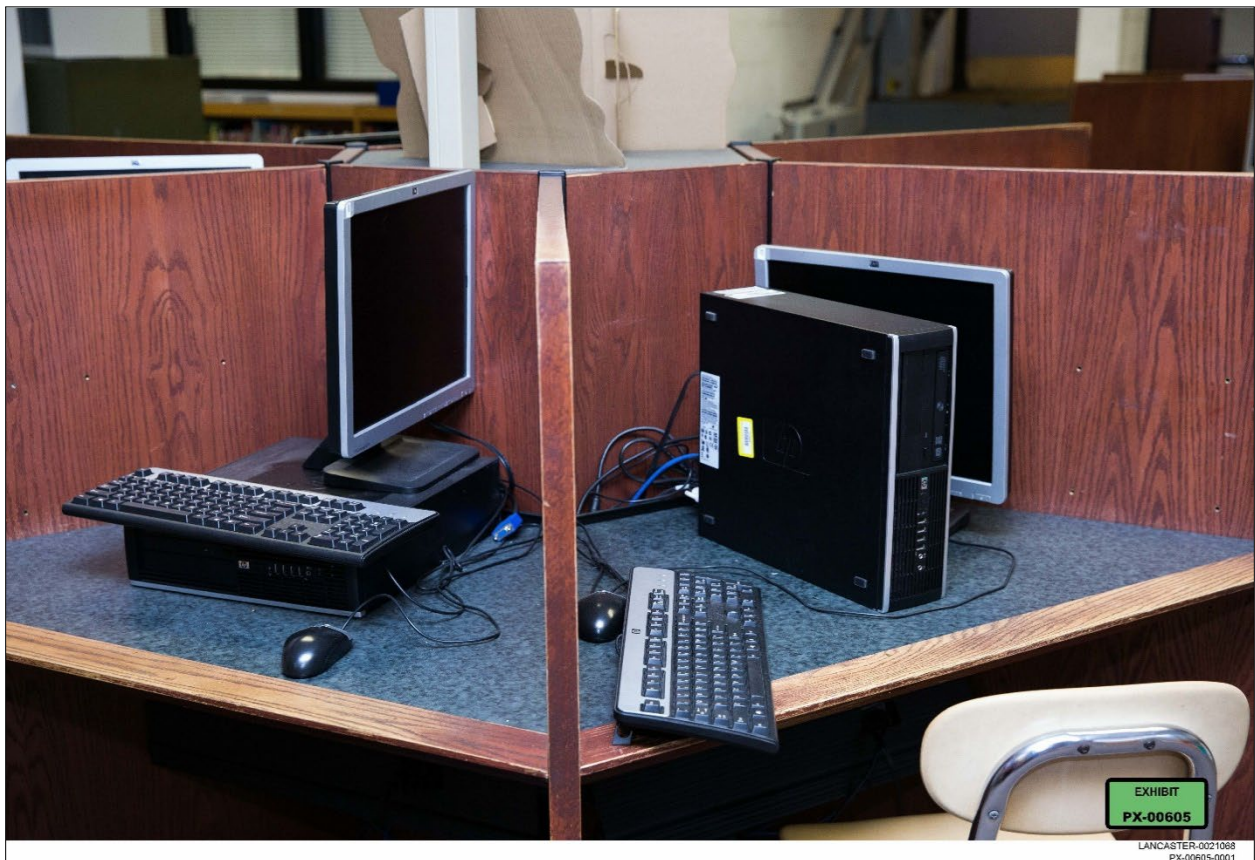
**PX-605** depicts the outdated technology and computers available at Wickersham Elementary in the School District of Lancaster in March 2020, just before the COVID pandemic, which were largely not in use because they were outdated. Tr. 5780:12-22 (Przywara). This photo was taken in the basement of Wickersham, which was converted into a library because the school did not have the room to make a library on the main floors. Tr. 5780:23-5781:6 (Przywara). The state of Wickersham ultimately required the district to renovate the building. Tr. 5776:12-5777:6 (Przywara).

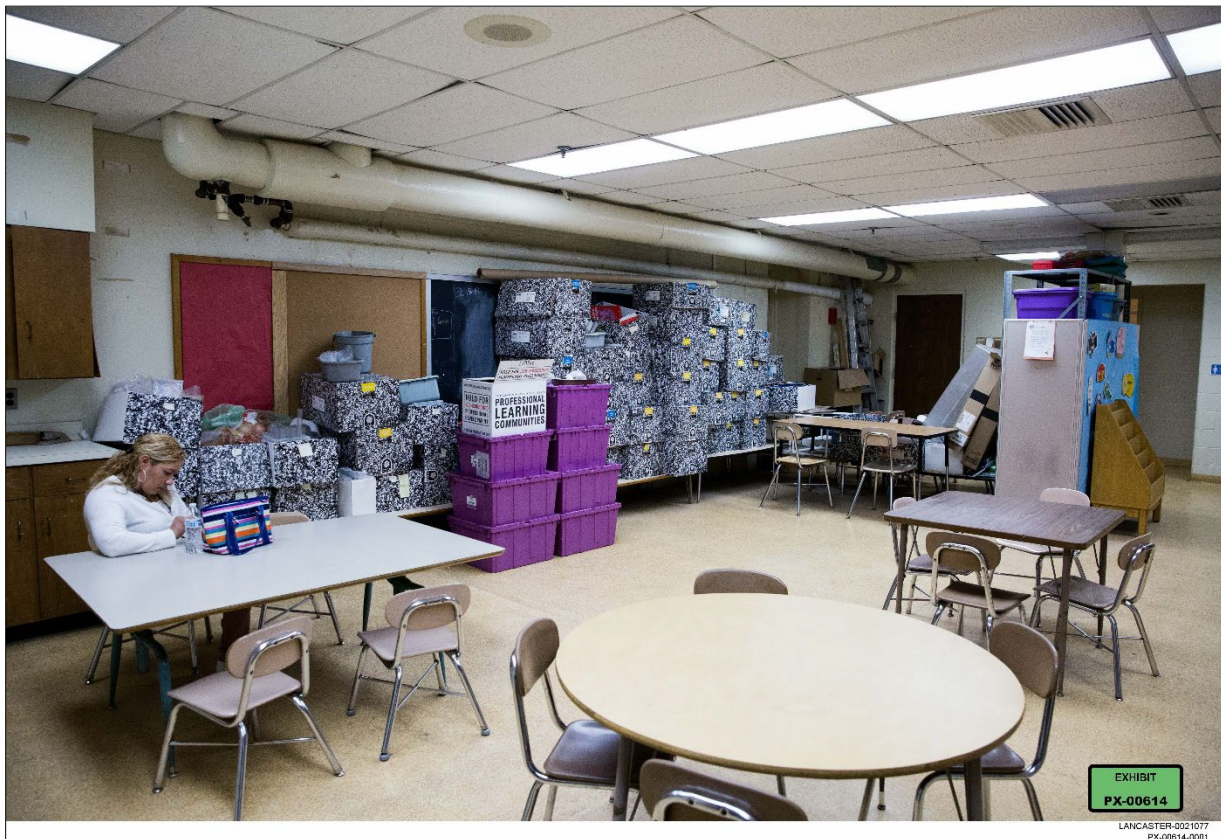
**PX-614** depicts a classroom learning space for kindergartners in the basement of Wickersham Elementary School in the School District of Lancaster, which also serves as a storage space for supplies. Tr. 5784:4-16 (Przywara). Students used this as their daily classroom. Tr. 5784:4-16 (Przywara). The state of Wickersham ultimately required the district to renovate the building. Tr. 5776:12-5777:6 (Przywara).

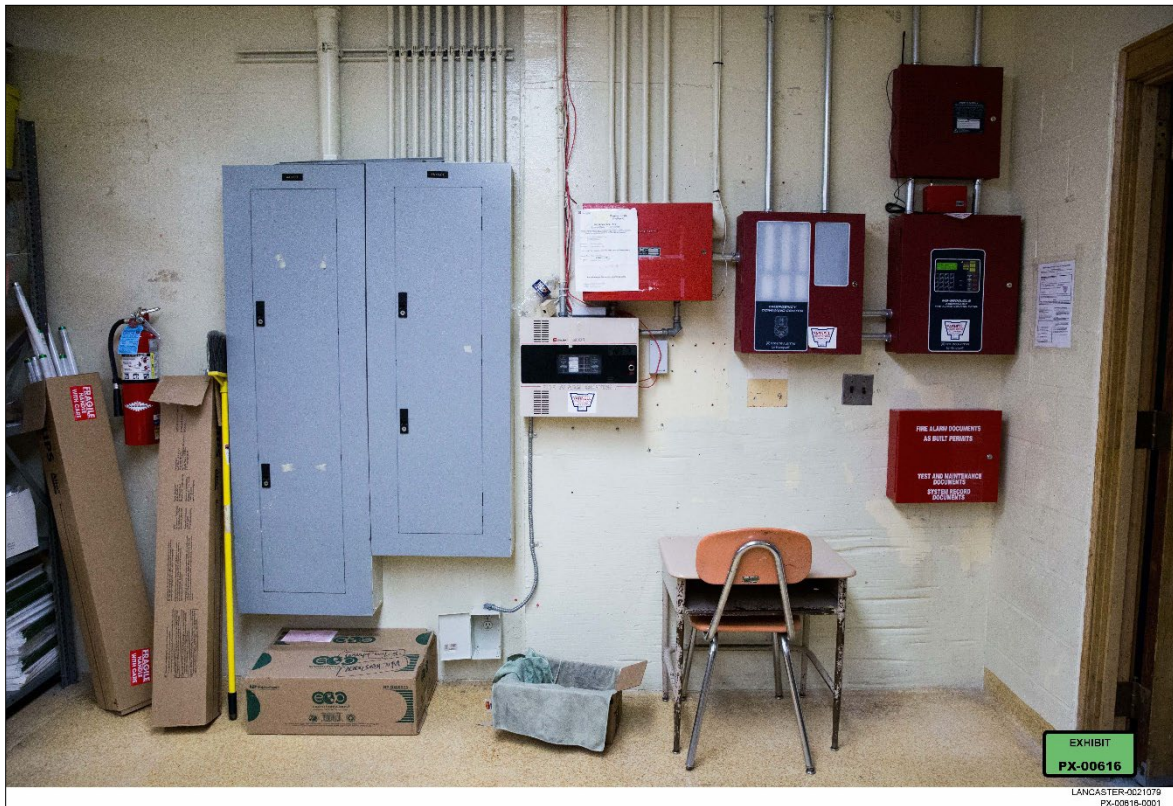
**PX-616** depicts a student desk, which was used for individual work or one-on-one instruction at Wickersham Elementary School in the School District of Lancaster, positioned between various electrical panels and alarm system. Tr. 5784:19-5785:9 (Przywara). The state of Wickersham ultimately required the district to renovate the building. Tr. 5776:12-5777:6 (Przywara).

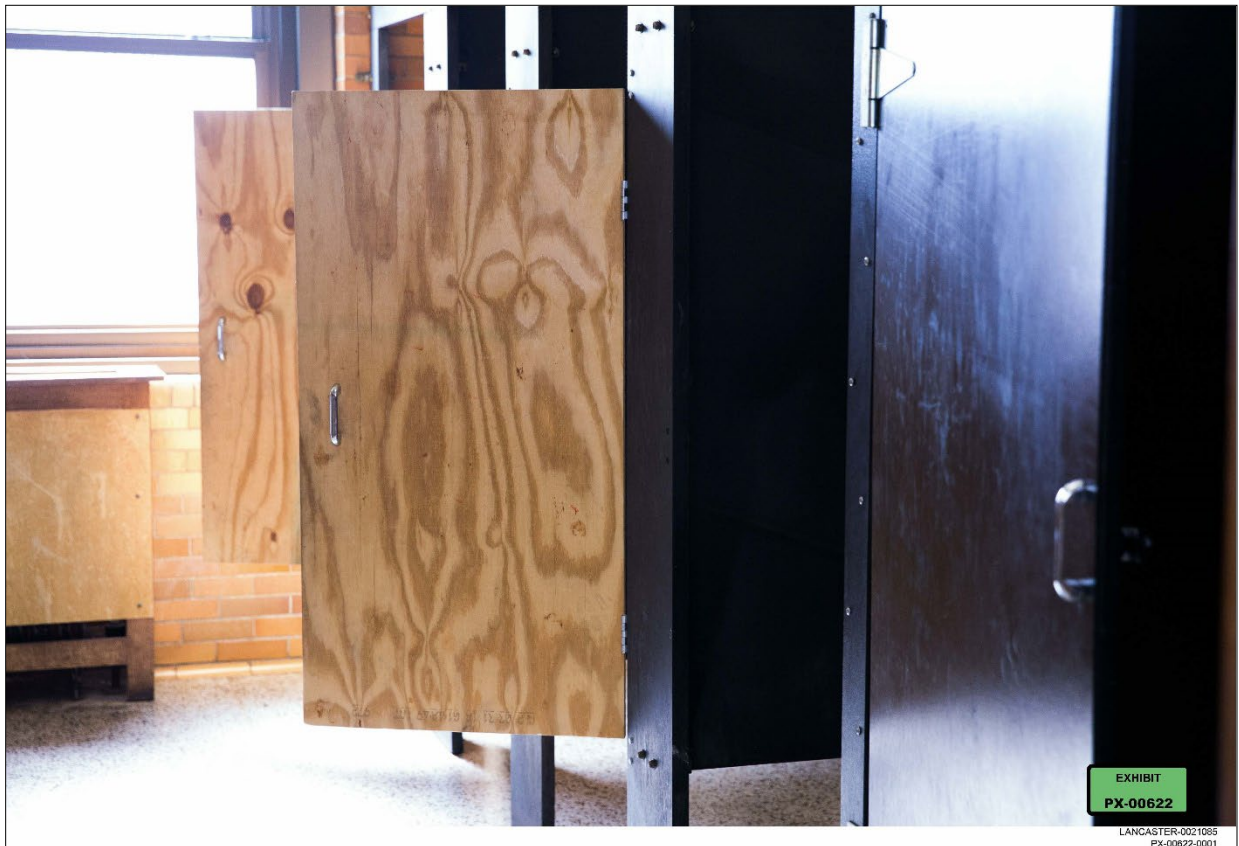
**PX-622** depicts the bathroom at Wickersham Elementary in the School District of Lancaster, where many stalls do not have doors for privacy. Instead of recreating the entire bathroom, staff constructed makeshift plywood doors of exhibit. Tr. 5779:15-5780:3 (Przywara). The state of Wickersham ultimately required the district to renovate the building. Tr. 5776:12-5777:6 (Przywara).

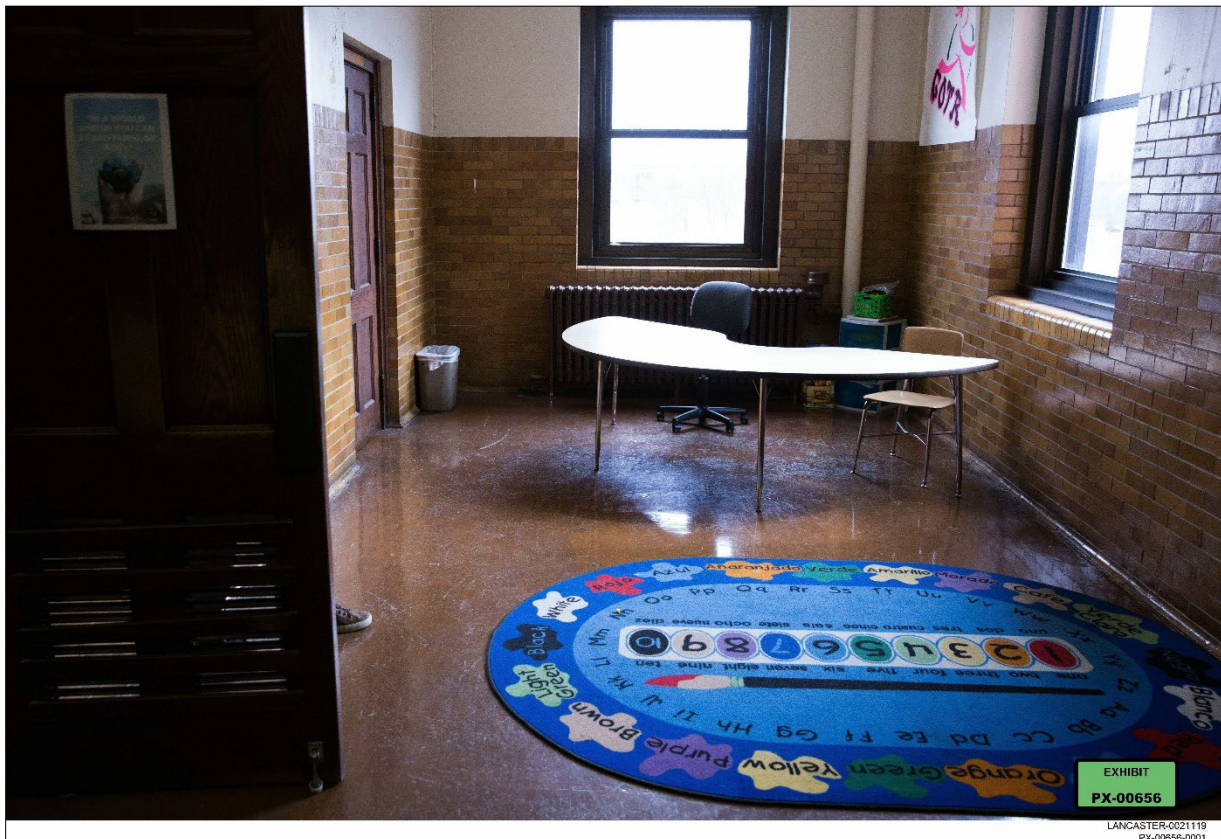
**PX-656** depicts a hallway at Wickersham Elementary in the School District of Lancaster where teachers would provide individual reading or math interventions. Tr. 5782:23-5783:14 (Przywara). Wickersham Elementary did not have the adequate space or facilities to otherwise provide small group interventions. Tr. 5783:1-14 (Przywara). The state of Wickersham ultimately required the district to renovate the building. Tr. 5776:12-5777:6 (Przywara).

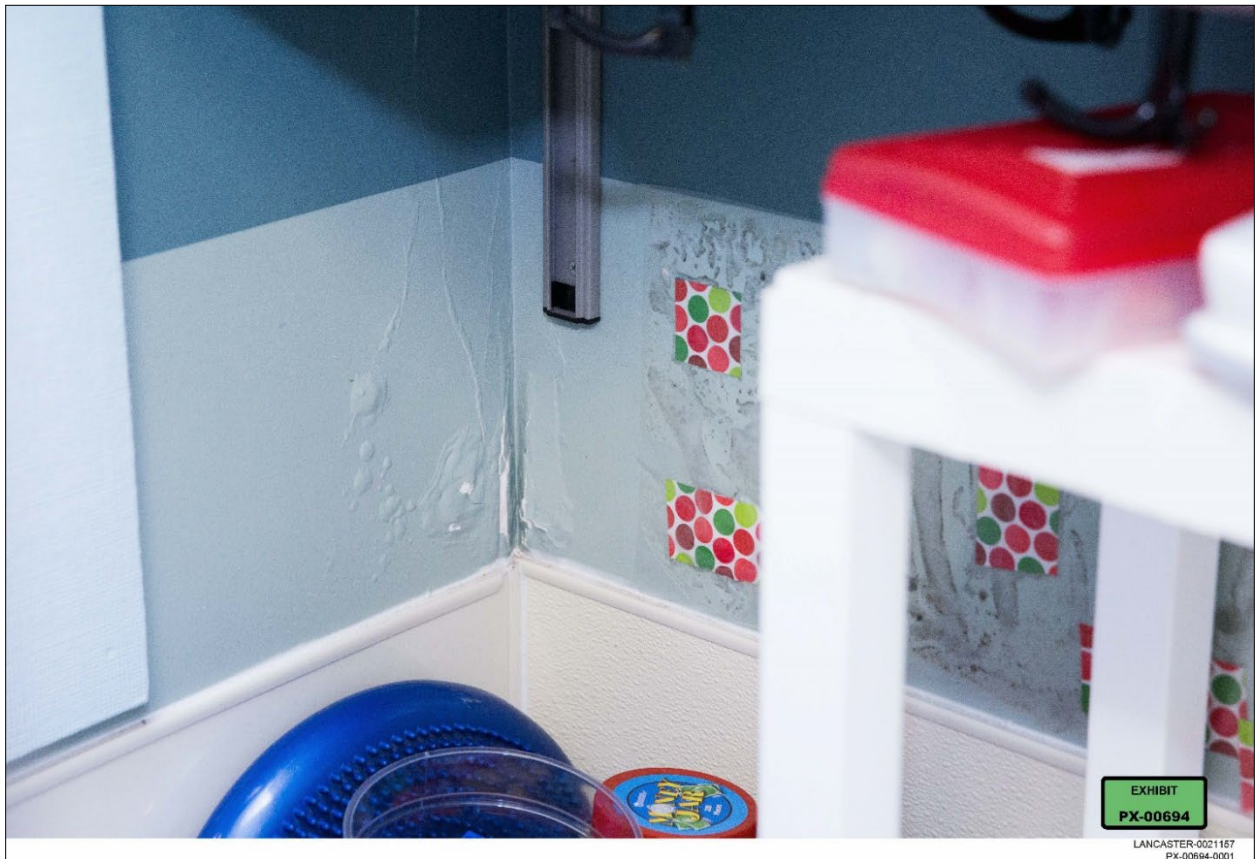
**PX-694** depicts a corner of a special education classroom where staff have tried to obscure moisture bubbles in the wall by repainting the corner and covering with various elements at Carter & Macrae Elementary School in the School District of Lancaster. Tr. 5788:23-5789:11 (Przywara). This is an accurate representation of Carter & MacRae today. Tr. 5789:12-14 (Przywara).

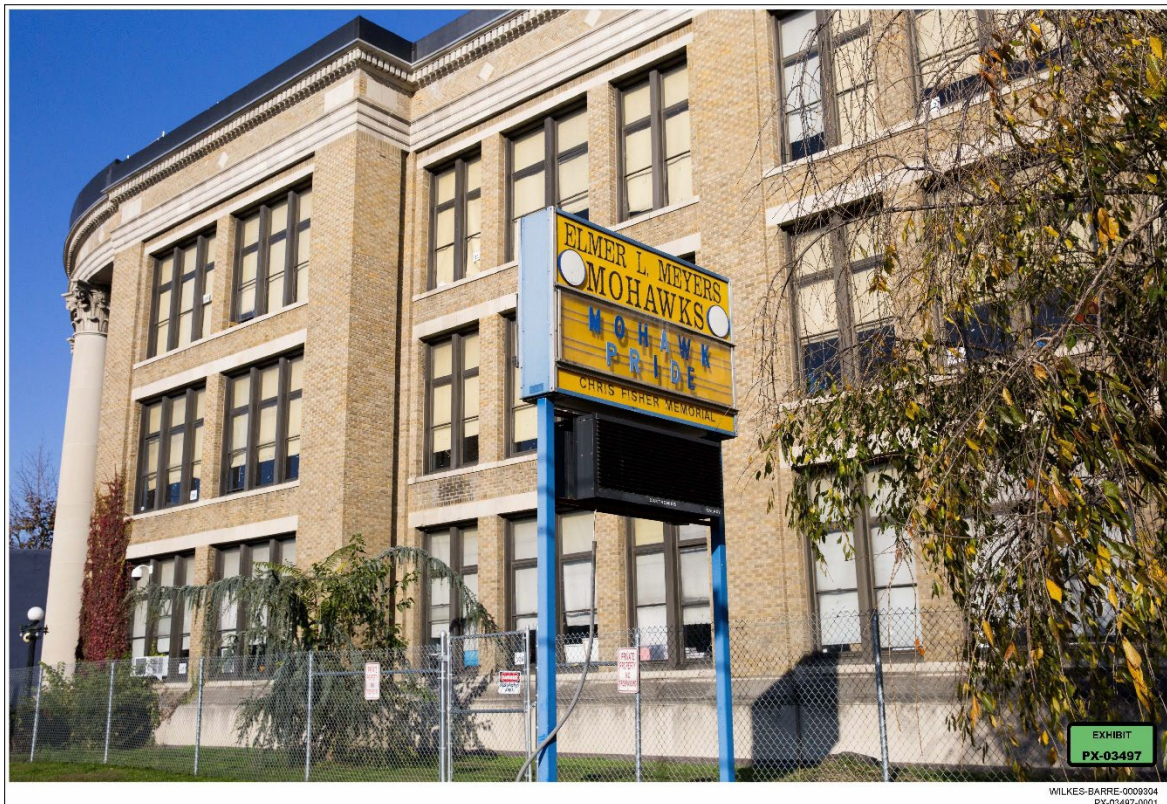
**PX-3497** depicts Meyers High School, in Wilkes-Barre Area School District, with fencing around the perimeter to protect students and pedestrians from being struck by eroding masonry and debris. Tr. 10696:15-10697:6 (Costello). At the top of the exterior wall, there is a black band, nicknamed the “Black Band-Aid,” which the school installed to support the parapet before it began eroding, however ultimately was unable to resolve safety concerns. Tr. 10697:7-18 (Costello). Wilkes-Barre Area School District has since closed Meyers High School due to unsafe conditions and budget constraints. Tr. 10694:7-10695:9 (Costello); 10696:19-20 (Costello).

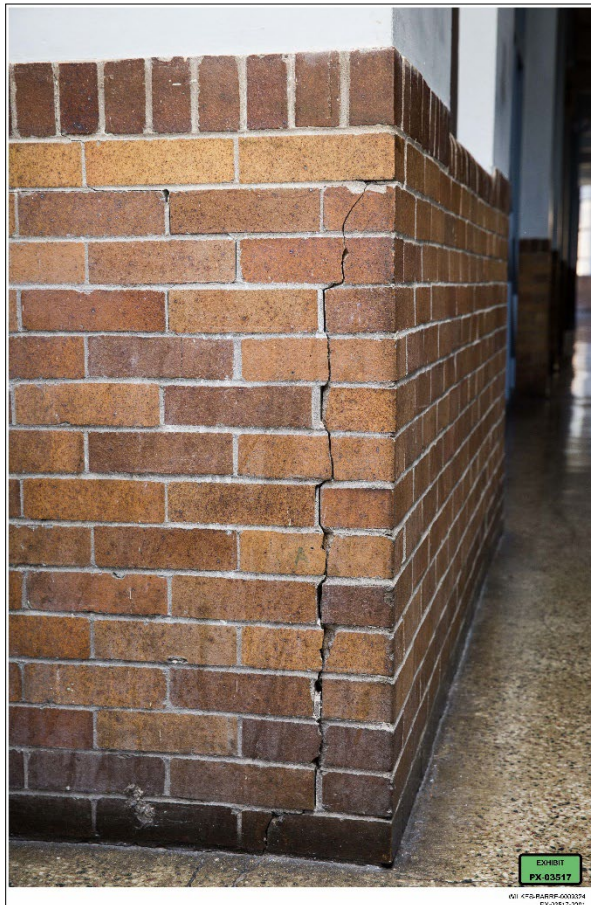
**PX-3517** depicts stress cracks in the wall at Meyers High School in Wilkes-Barre Area School District, which occurred because the building foundation shifted 12 inches over time. Tr. 10702:1-10703:7 (Costello). This shift created twisting within the building, and was exacerbated by water flowing into the building due to cracks which the district could not seal. Tr. 10702:4-24 (Costello). Wilkes-Barre Area School District has since closed Meyers High School due to unsafe conditions and budget constraints. Tr. 10694:7-10695:9; 10696:19-20 (Costello).

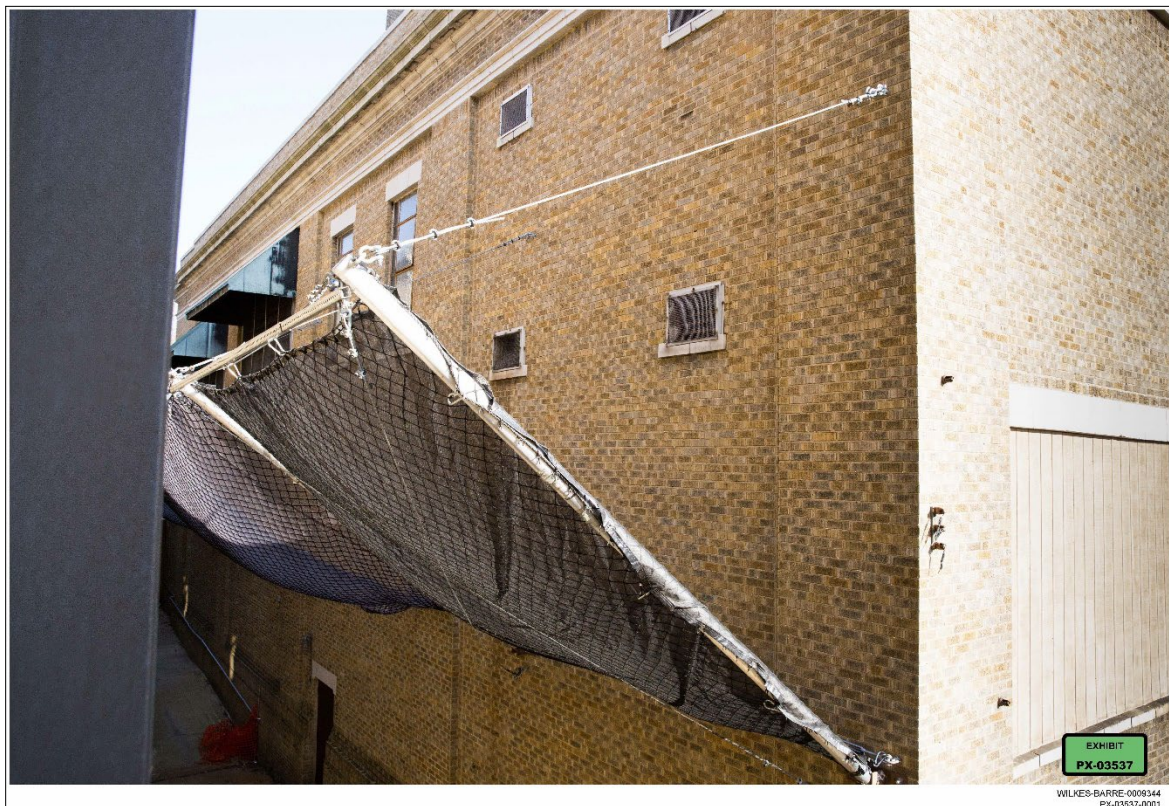
**PX-3537** depicts a safety net, which was installed at Meyers High School in Wilkes-Barre Area School District, to protect students, pedestrians, and vehicles from loose debris which was falling from the building's unmaintained parapet. Tr. 10708:21-10709:21 (Costello). Wilkes-Barre Area School District has since closed Meyers High School due to unsafe conditions and budget constraints. Tr. 10694:7-10695:9; 10696:19-20 (Costello).

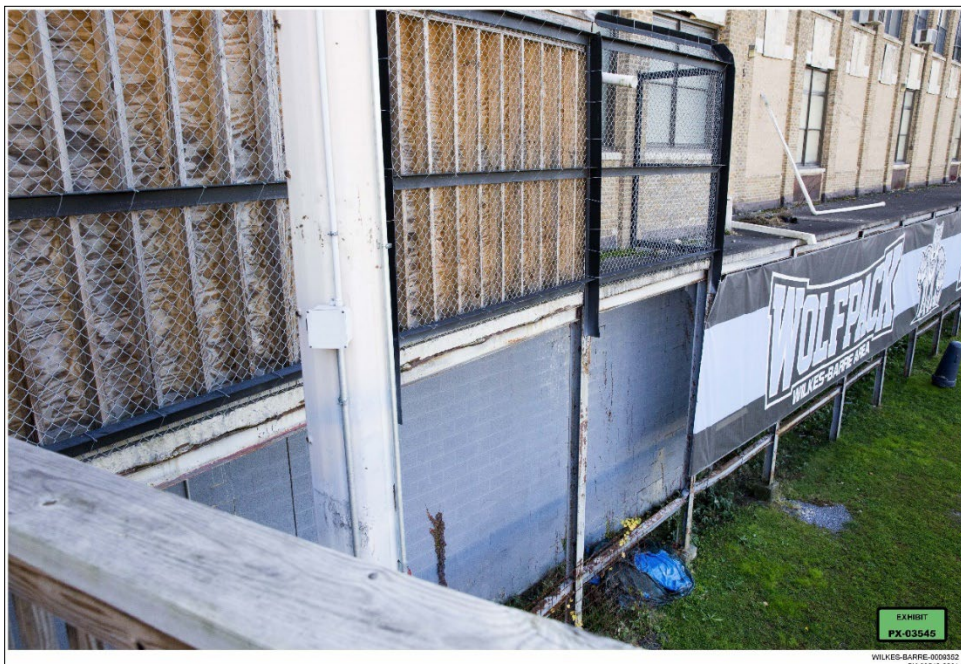
**PX-3545** depicts the outside of the cafeteria at Meyers High School in Wilkes-Barre Area School District. This area previously housed bleachers attached to the metal frames, but, after machinery fell through the concrete walkway now enclosed by the second-floor fence, an inspection revealed that steel in that area was severely delaminating and the entire structure could collapse, requiring the school to remove the bleachers. Tr. 10710:4-10711:24 (Costello). Above the furthest right point of the second-story fence is a piece of stonework which has deteriorated, cracked and fallen. Tr. 10712:10-23 (Costello). The black fencing is a protective shed that had to be installed to protect students from such debris. Tr. 10712:1-9 (Costello). Wilkes-Barre has since closed Meyers High School due to unsafe conditions and budget constraints. Tr. 10694:7-10695:9 (Costello); 10696:19-20 (Costello).

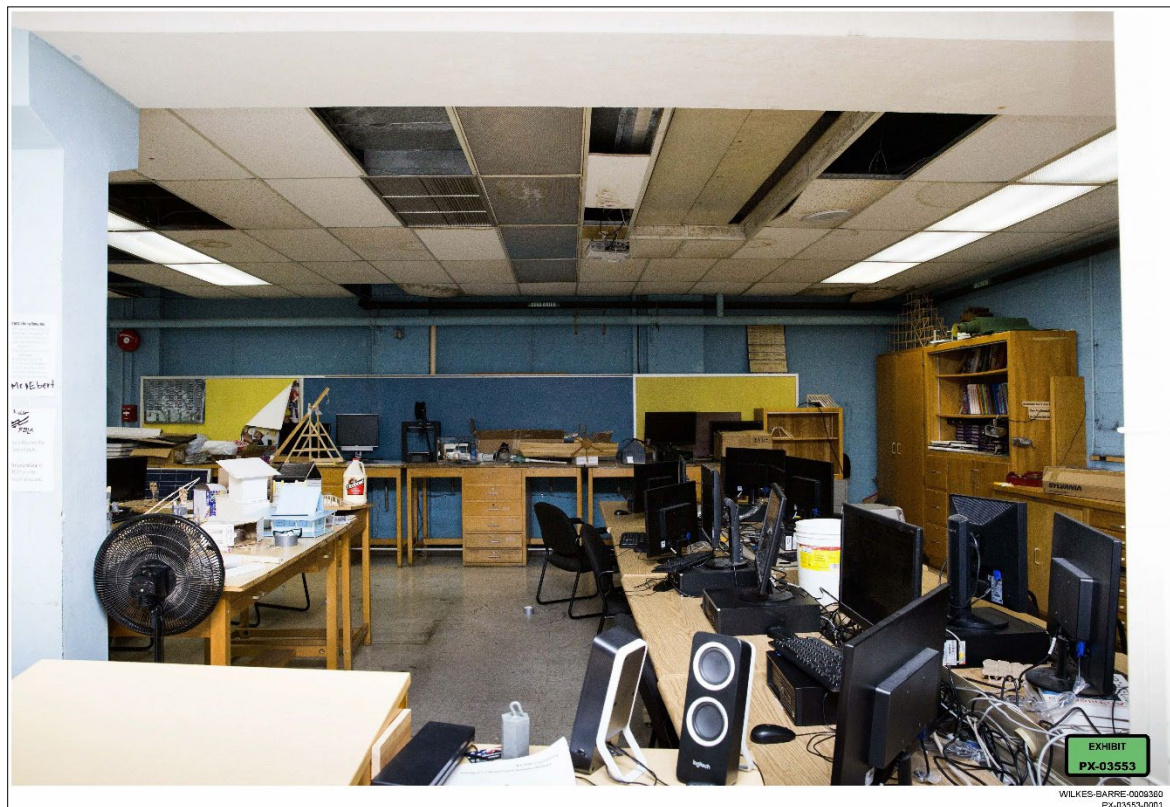
**PX-3553** depicts the STEM Academy at Meyers High School in Wilkes-Barre Area School District. Tr. 10713:17-10715:6 (Costello). This image also shows a bucket on the table among the wires, which was used to collect water dripping from the ceiling as a result of a leak that the school could not seal. Tr. 10714:10-17 (Costello). The ceilings of the room are deteriorated and stained from water damage. Tr. 10714:1-22 (Costello). Wilkes-Barre Area School District has since closed Meyers High School due to unsafe conditions and budget constraints. Tr. 10694:7-10695:9 (Costello); 10696:19-20 (Costello).

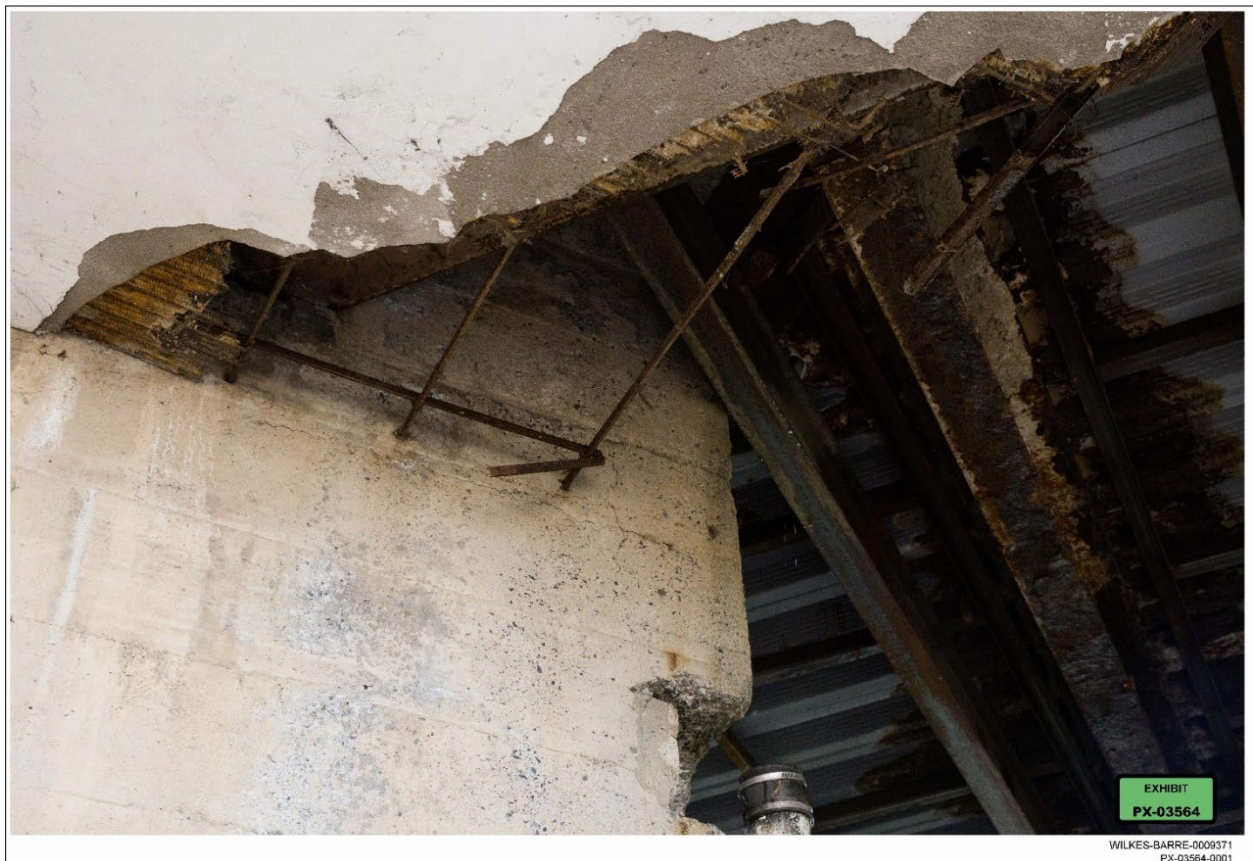
**PX-3564** depicts the underside of a crosswalk that students would use to travel from the Meyers High School auditorium in Wilkes-Barre Area School District to the cafeteria. Tr. 10718:1-24 (Costello). The erosion and delamination affecting the steel supports eventually forced the school to close the walkway due to concerns that the crosswalk would collapse. Tr. 10718:5-24 (Costello). Wilkes-Barre Area School District has since closed Meyers High School due to unsafe conditions and budget constraints. Tr. 10694:7-10695:9; 10696:19-20 (Costello).

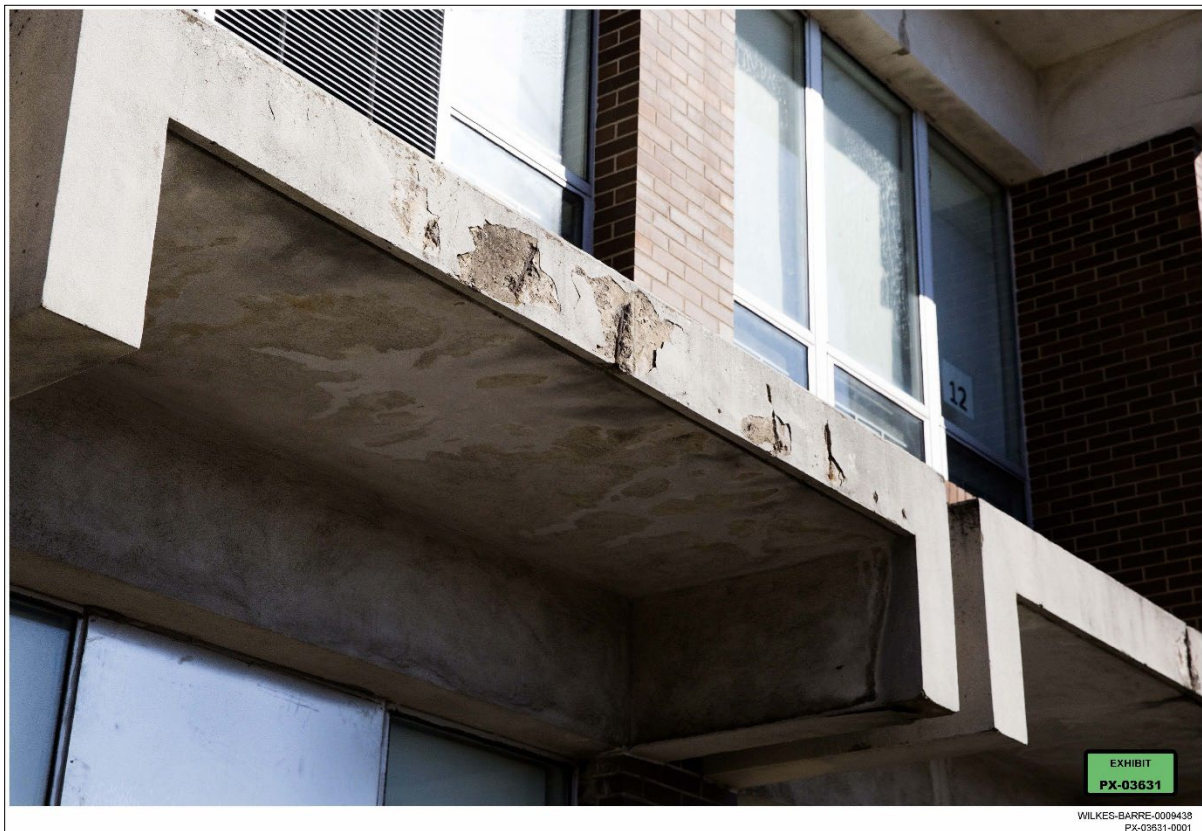
**PX-3631** depicts the exterior of Flood Elementary, in Wilkes-Barre Area School District. Tr. 10801:13-10802:1 (Costello). The building's steel is beginning to delaminate and the concrete is beginning to crumble. Tr. 10801:17-10802:1 (Costello). This is an accurate representation of Flood Elementary today. Tr. 10820:7-11 (Costello).

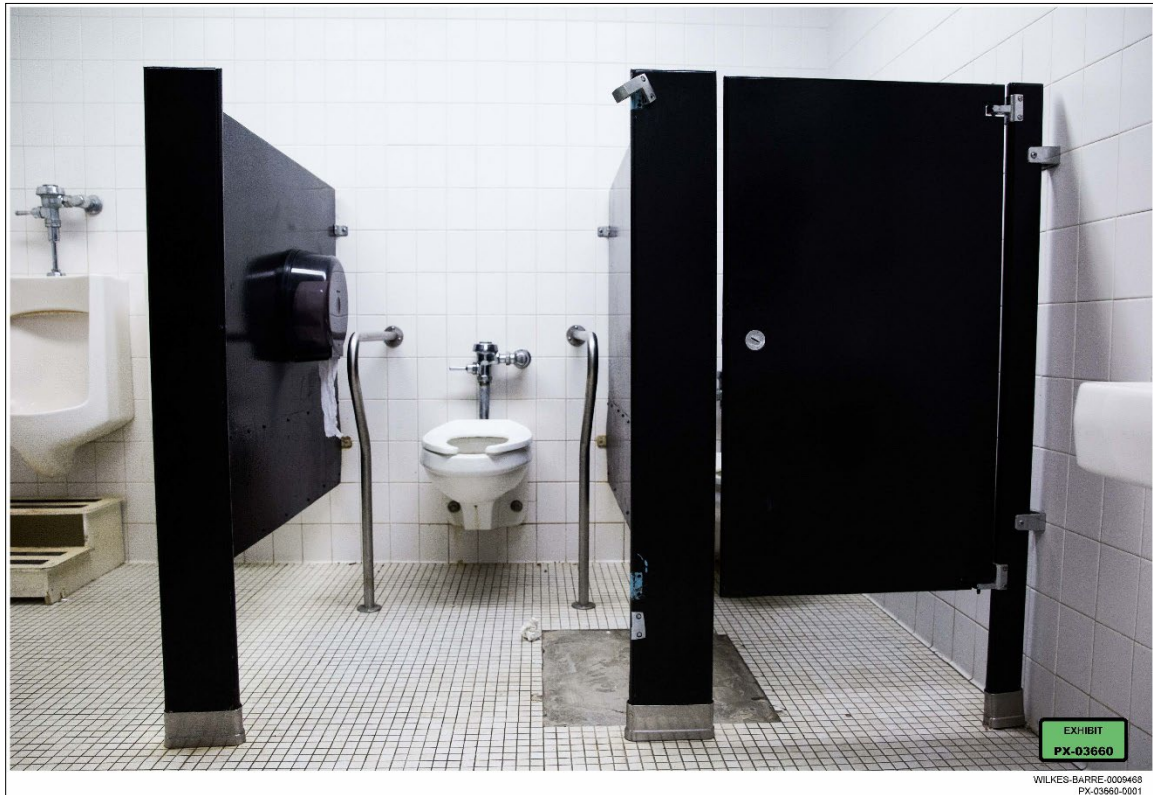
**PX-3660** depicts a bathroom, which has no door and is missing flooring tile, of Heights Elementary in Wilkes-Barre Area School District. Tr. 10803:23-10804:20. While the door has been temporarily repaired, the district has not yet been able to replace the missing flooring tile. Tr. 10804:8-20 (Costello).

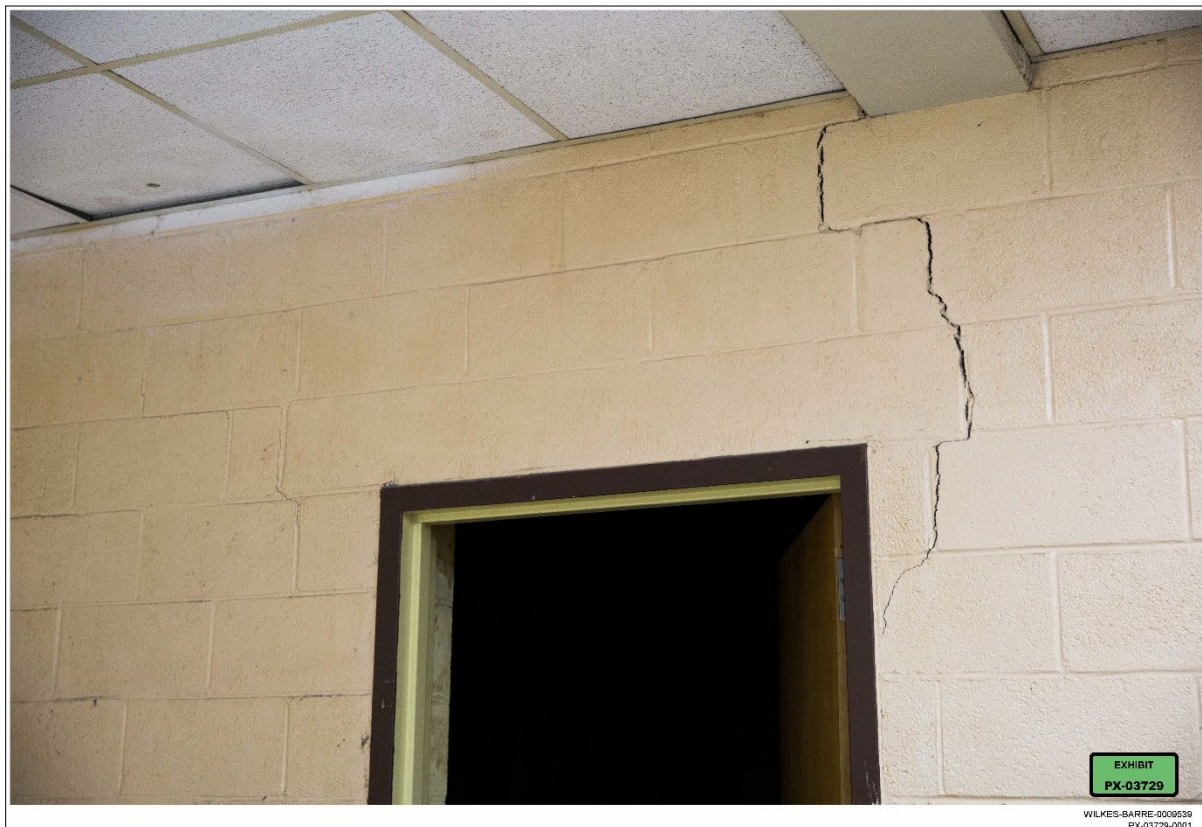
**PX-3729** depicts a settlement crack in the wall that has resulted from shifting in the Kistler Elementary's foundation in Wilkes-Barre Area School District, in a manner similar to those that rendered Meyers High School unusable. Tr. 10809:1-10810:12 (Costello). The ceiling and wall also have slight marks of white spray paint because the school tried to paint over the water damage on ceiling tiles. Tr. 10810:4-12 (Costello). This accurately depicts current conditions at Kistler Elementary. Tr. 10820:22-10821:2 (Costello).

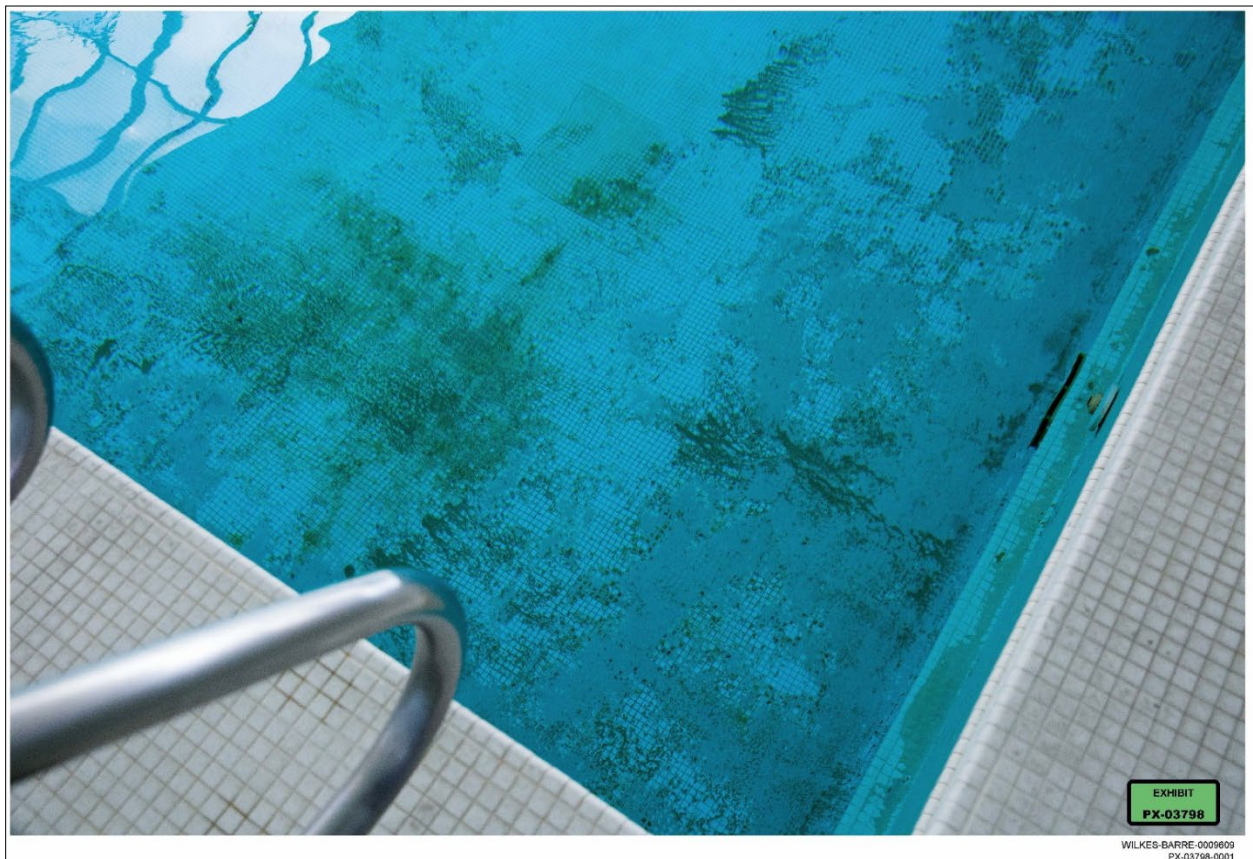
**PX-3798** depicts the natatorium at Kistler Elementary in Wilkes-Barre Area School District, which needs extensive work. Tr. 10813:17-10814:16 (Costello)

The area did not have any heat on the deck, and so the school had to bring in blowers to adequately heat the area for swimmers. Tr. 10813:24-10814: 6 (Costello). The school was additionally unable to properly repair the leaks and cracks in the tiles. Tr. 10814:7-16 (Costello). This accurately depicts current conditions at Kistler Elementary. Tr. 10820:22-10821:2 (Costello).

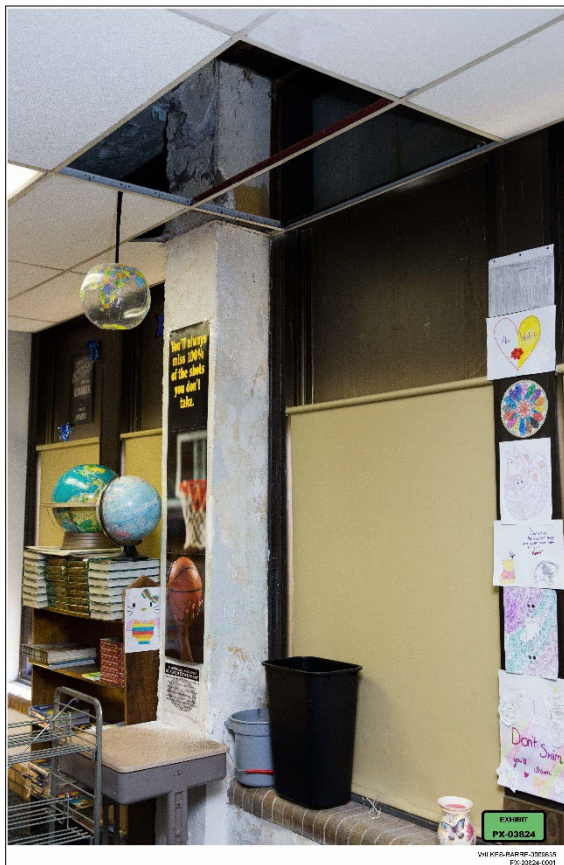
**PX-3824** depicts a classroom at GAR Middle School in Wilkes-Barre Area School District with extensive water damage from water leaking from the ceiling that has deteriorated several ceiling tiles and caused the plaster to flake off of the column. Tr. 10815:21-10816:15 (Costello). The classroom has buckets positioned underneath the open ceiling to collect dripping water. Tr. 10816:1-15 (Costello). This accurately depicts current conditions at GAR Middle School. Tr. 10821:11-15 (Costello).

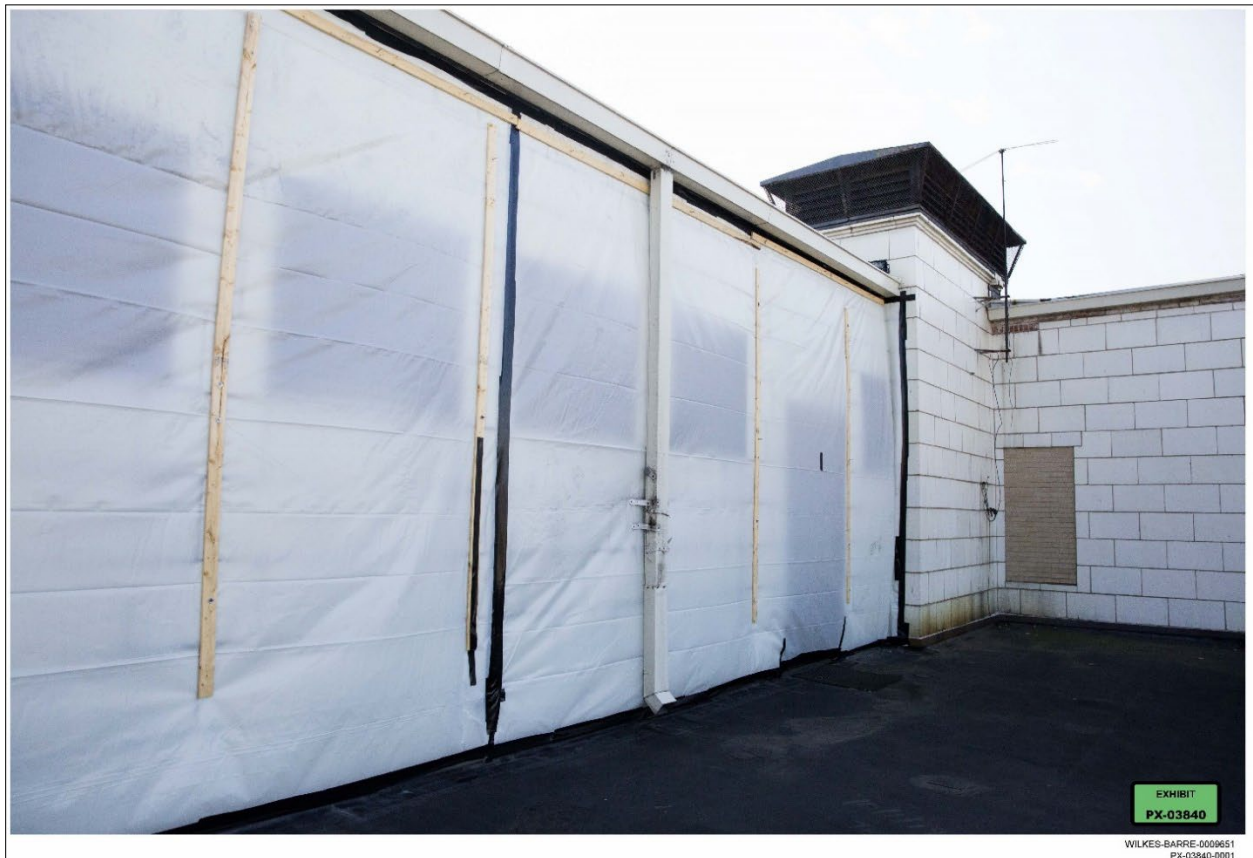
**PX-3840** depicts the roof area outside of GAR Middle School in Wilkes-Barre Area School District, which has plastic sheeting protecting the doors and windows of the rooftop access building to prevent water seeping in. Tr. 10816:19-10817:14 (Costello). The school has been unable to fund the proper maintenance required to water-seal this building, and so they have used plywood and plastic as an alternative measure to try and prevent water from seeping in and flooding the floors below. Tr. 10816:23-10817:10 (Costello). This accurately depicts current conditions at GAR Middle School. Tr. 10821:11-15 (Costello).

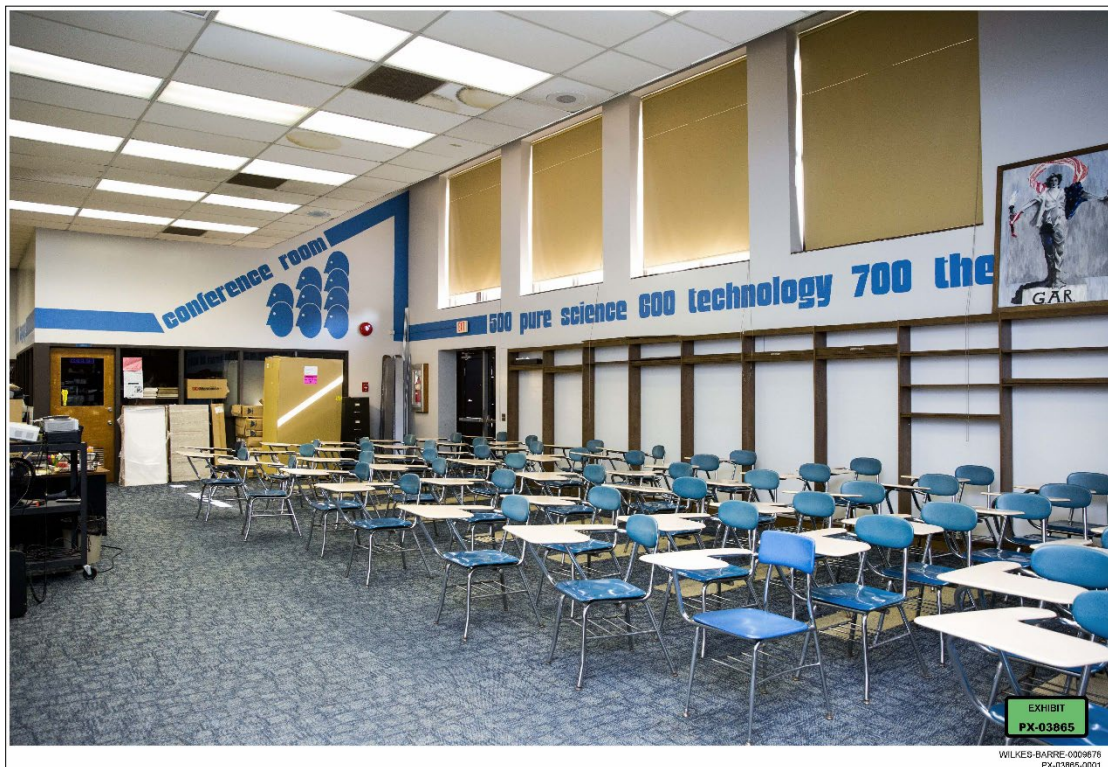
**PX-3865** depicts the former library at GAR Middle School in Wilkes-Barre Area School District, which has been converted into a makeshift classroom. Tr. 10817:16-10818:11 (Costello). The ceiling has been stained and corroded by water damage due to a roof leak, and therefore is missing ceiling tiles. Tr. 10817:20-10818:8 (Costello). This accurately depicts current conditions at GAR Middle School. Tr. 10821:11-15 (Costello).

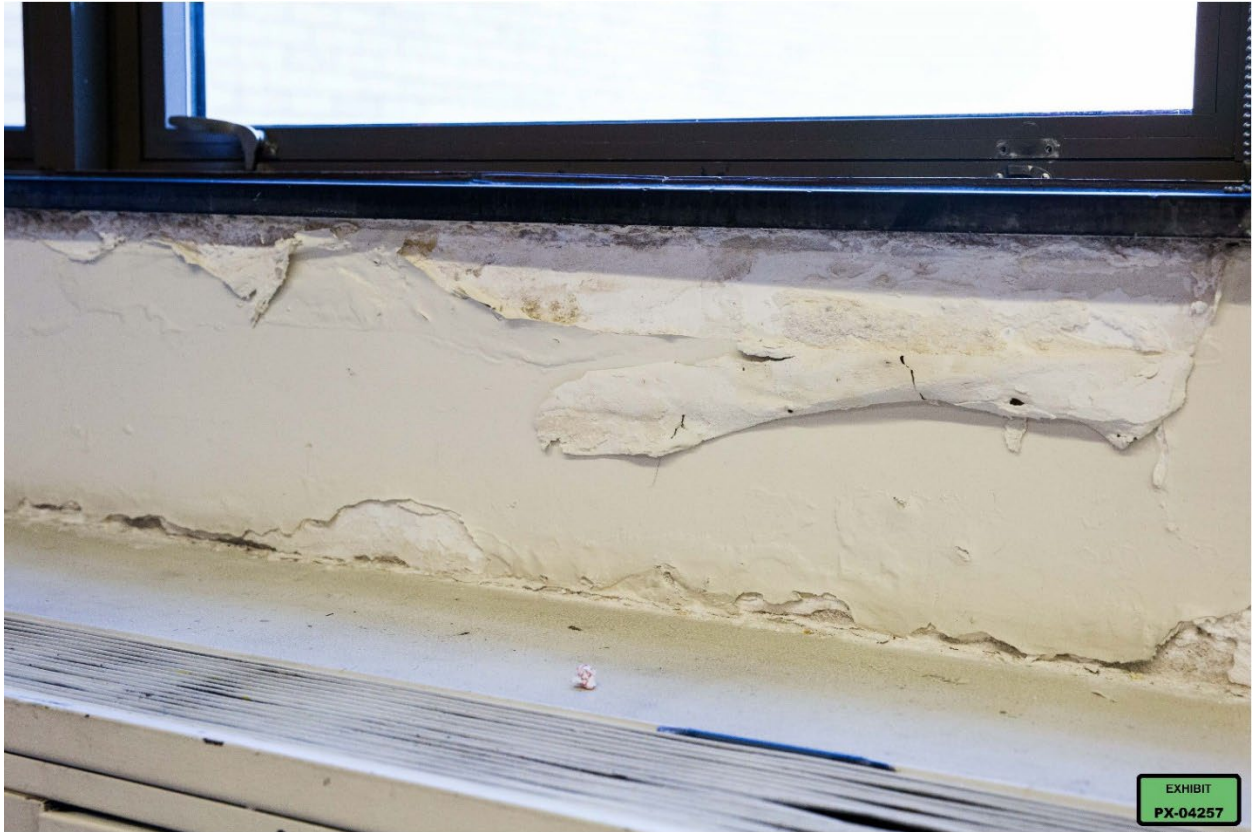
EXHIBIT  
**PX-04257**

**PX-4258** depicts a paint and plaster peeling off a classroom wall because of moisture damage at Penn Wood, Green Avenue campus in William Penn School District. Tr. 7005:2-22 (Harbert). The heating system in this exhibit is coming loose, the top is bent, and the system is in disrepair. Tr. 7005:15-22 (Harbert). The wall has been recently painted, but the heating vent accurately reflects the condition of the auditorium when former superintendent Harbert visited two weeks prior to her testimony. Tr. 7002:10-22 (Harbert).

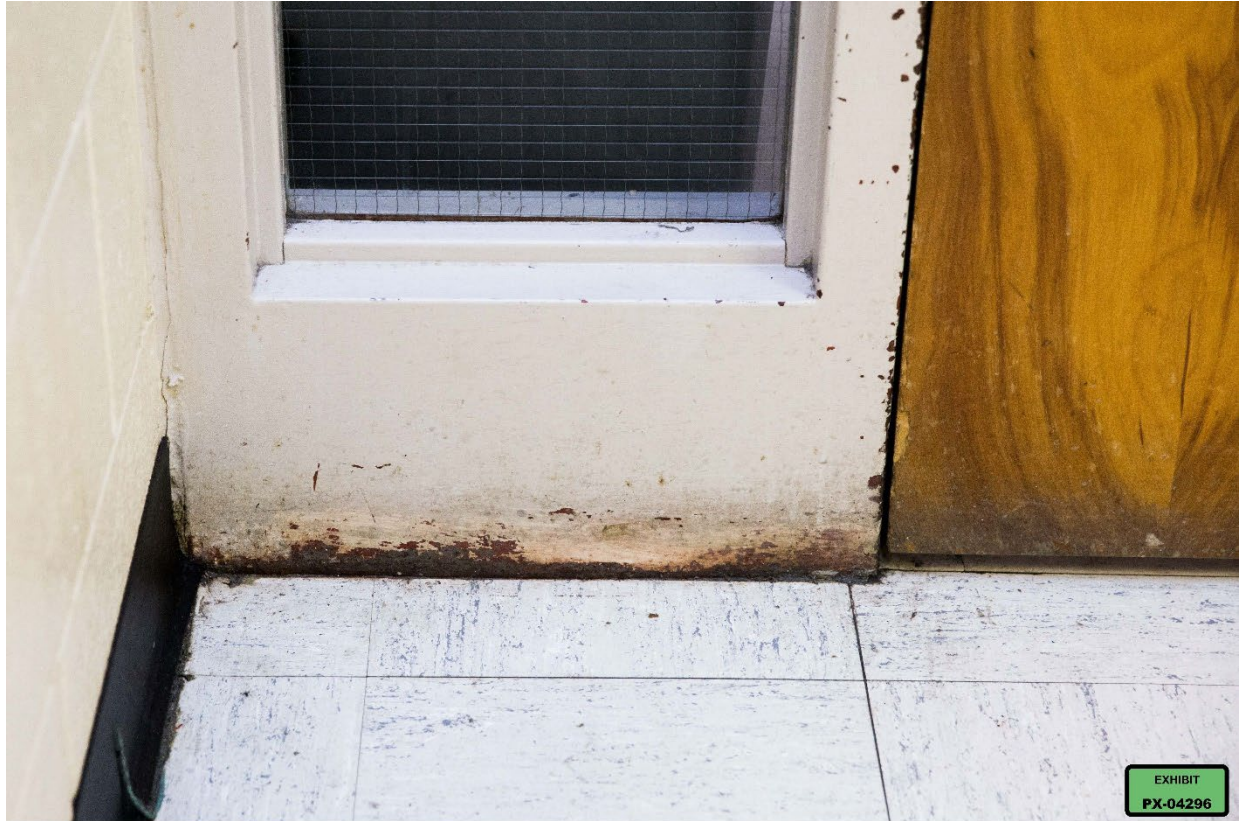
EXHIBIT  
**PX-04296**  
WILLPENN-0012486  
PX-04296-0001

**PX-4296** depicts a rusted, corroded metal panel that is peeling away from the wall due to moisture problems in a first grade classroom in William Penn School District. Tr. 7011:19-7012:15 (Harbert).

**PX-4297** depicts internet and telephone cables and wires running along the student stairwell wall in Walnut Elementary in William Penn School District. Tr. 7012:19-7013:15 (Harbert).
