IN THE COMMONWEALTH COURT OF PENNSYLVANIA

No. 587 MD 2014

# Appendix C

## Photographs Admitted Into Evidence by Petitioners

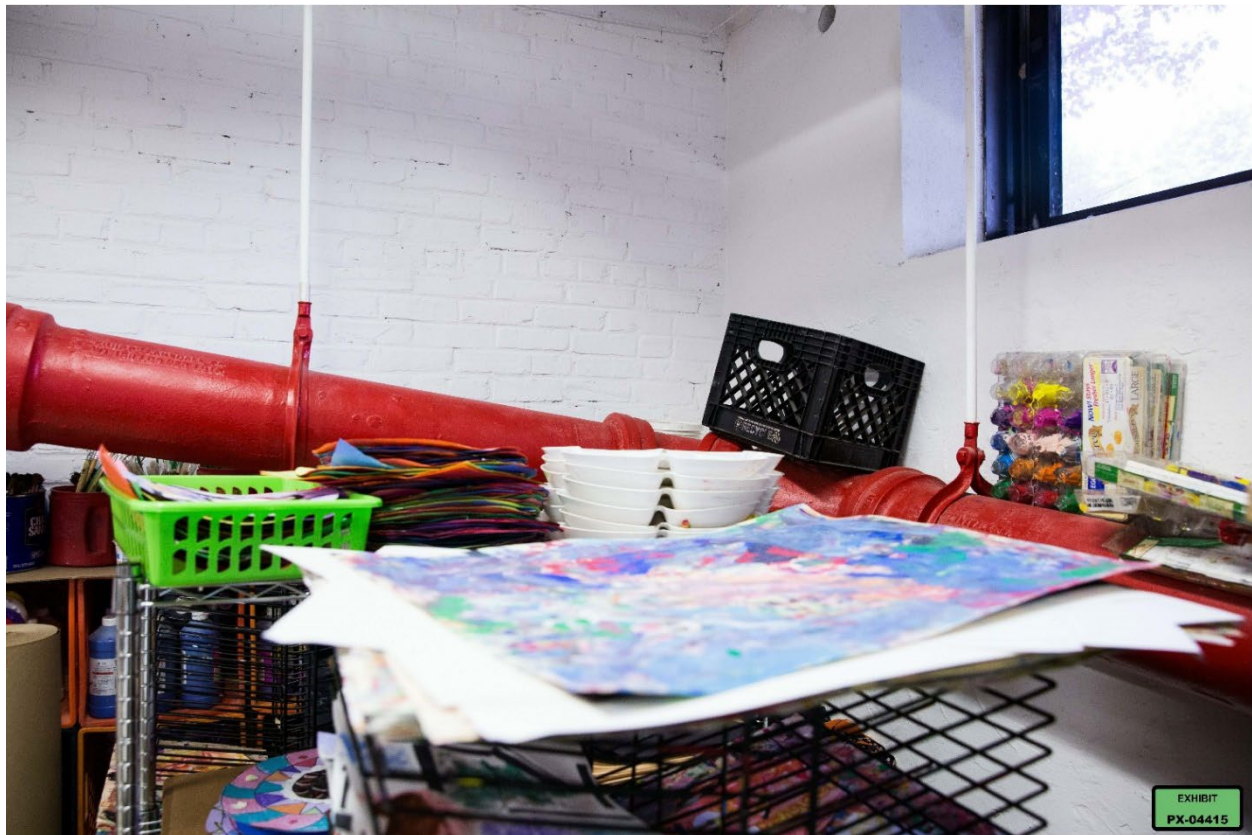
EXHIBIT  
PX-04415  
WILLPENN-0012805  
PX-04415-0001

**PX-4416** depicts the basement art room at East Lansdowne Elementary School in William Penn School District, which has a large, red drainage pipe running through the classroom towards the sump pump. Tr. 7015:8-10; 7015:14-7016:13 (Harbert). This accurately reflects the condition of the art room when former superintendent Harbert visited two weeks prior to her testimony. Tr. 7017:4-9 (Harbert).

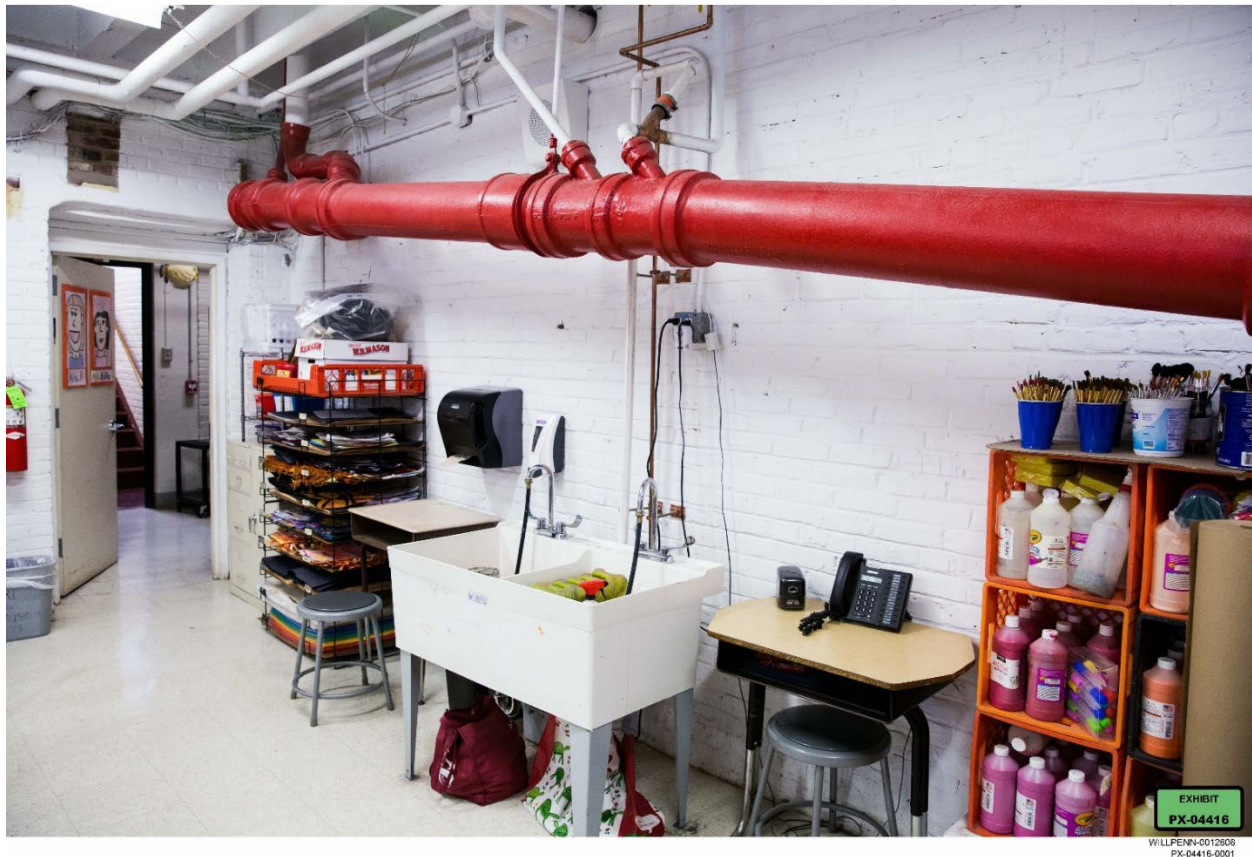
**PX-4417** depicts the basement art room at East Lansdowne Elementary School in William Penn School District, which has considerable uncovered wiring across the wall. Tr. 7015:8-10 (Harbert); 7016:17-7027:3 (Harbert). This accurately reflects the condition of the art room when former superintendent Harbert visited two weeks prior to her testimony. Tr. 7017:4-9 (Harbert).

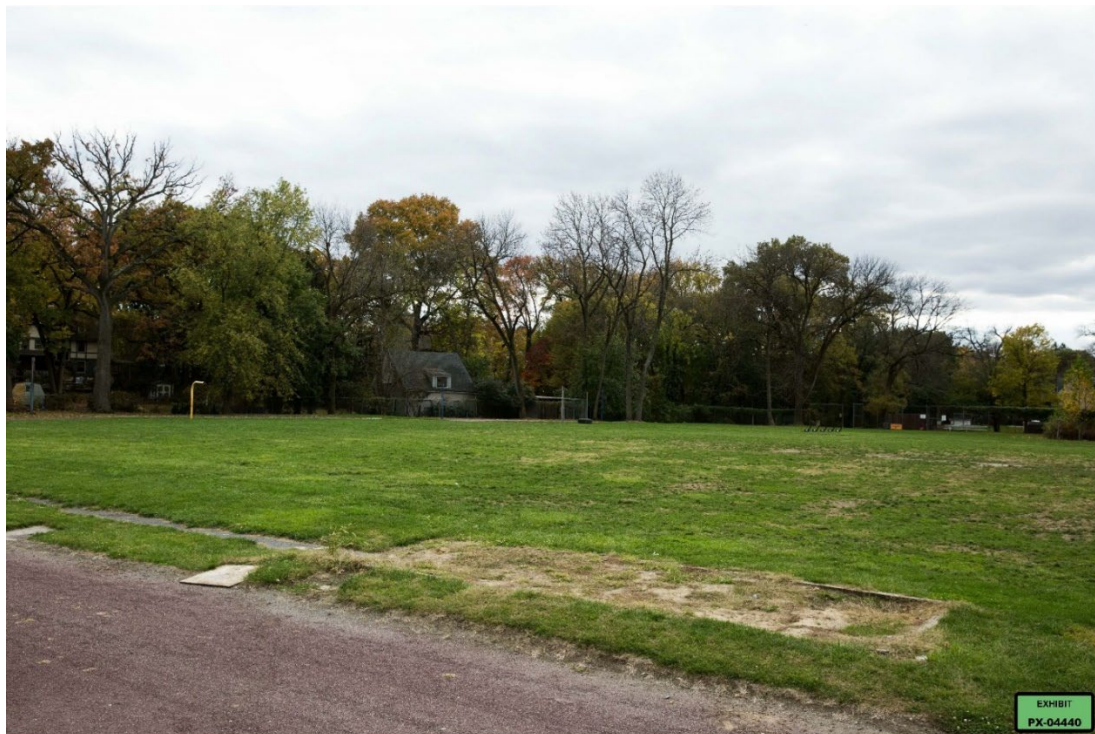
**PX-4440** depicts the football field, running track, and out-of-use long jump pit at William Penn School District's upperclassman high school. Tr. 6591:4-6592:15 (Curry). In the background is a blue pole, which was the former scoreboard until it became too old and was unsafe to remain in its position; the district has been unable to replace the board. Tr. 6591:23-6592:1 (Curry). The yellow pole is the former goal post, which was damaged after being struck by a tree in a storm; the district has been unable to replace the goal post. Tr. 6592:2-4 (Curry). The jump pit is no longer in use because it is not long enough or deep enough for athletes to safely use; the district is unable to replace the pit due to drainage issues on the field. Tr. 6592:7-15 (Curry). This reflects the current state of the field and track. Tr. 6592:16-20 (Curry).

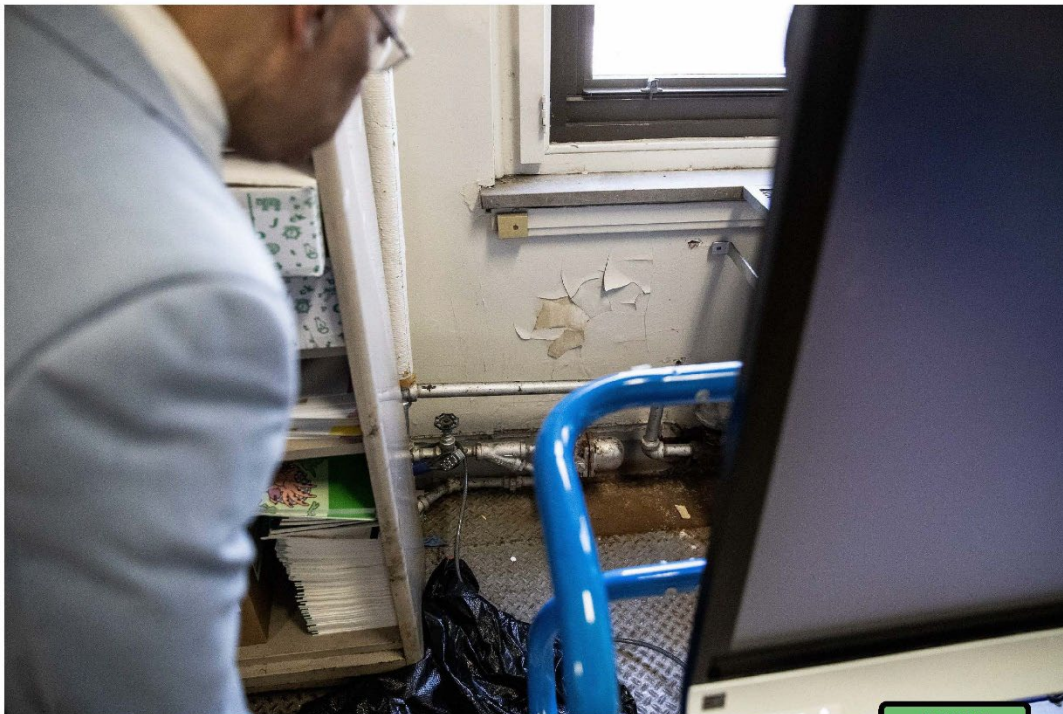
EXHIBIT  
**PX-00770**

**PX-770** depicts water intrusion affecting Roosevelt School in the School District of Philadelphia. Tr. 7800:19-7801:12 (Hite). The visible results of the water damage include peeling lead paint, which has led to lead paint chips on the floor, and rusting along the floor. Tr. 7800:19-7801:12 (Hite); 7801:24-7802:9 (Hite). Roosevelt has been able to remediate the lead paint issue, but approximately 75-80% of the over one hundred schools in the School District of Philadelphia still need lead paint remediation. Tr. 7802:15-24 (Hite).

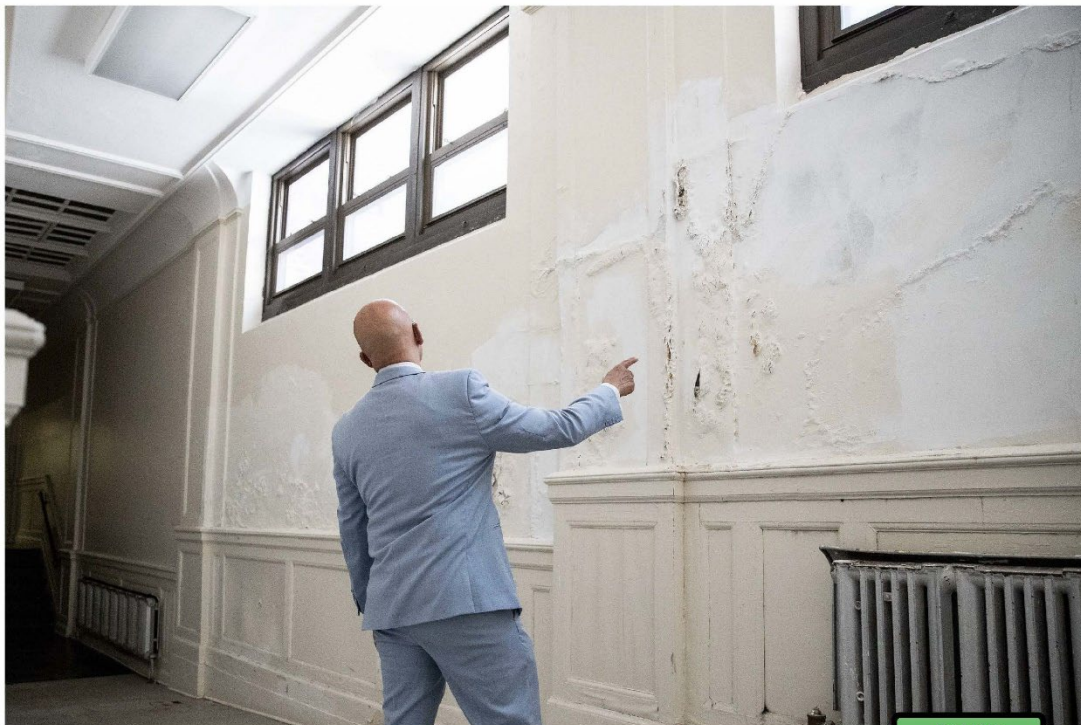
EXHIBIT  
**PX-00772**

**PX-772** depicts water intrusion affecting Roosevelt School in the School District of Philadelphia. Tr. 7804:4-13 (Hite). The visible results of the water damage include buckling and peeling lead paint, which increase the possibility of lead poisoning. Tr. 7804:10-13; 7805:5-17 (Hite). Water damage such as this also impact covering over asbestos materials, which creates additional health hazards. Tr. 7805:2-7806:5 (Hite).

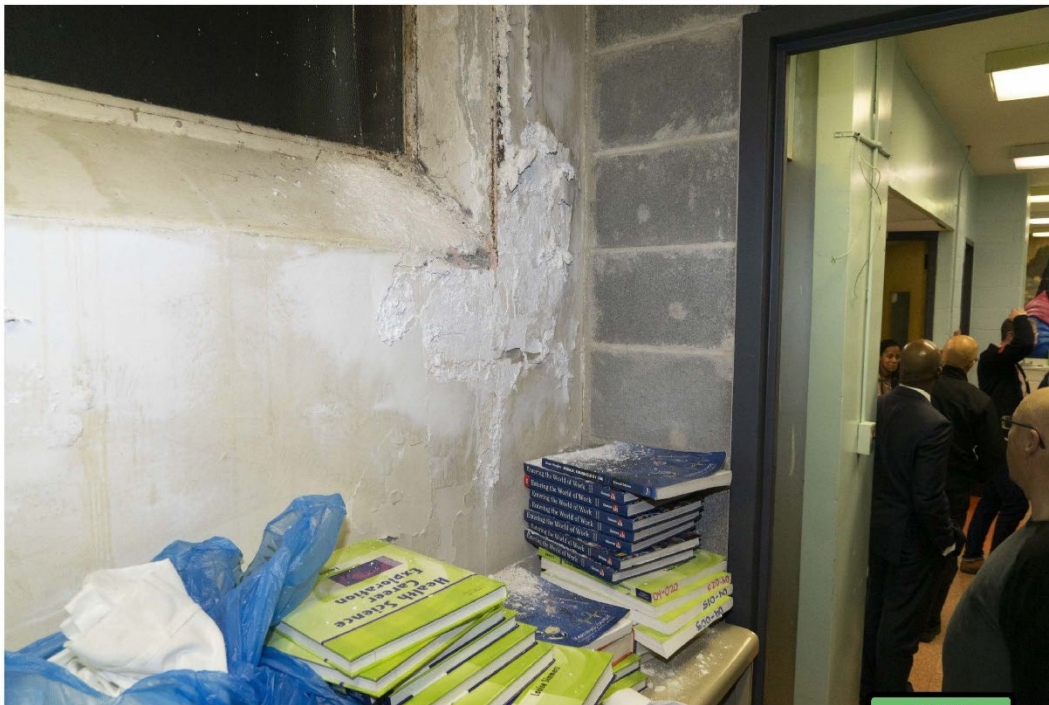
EXHIBIT  
**PX-00774**

**PX-774** depicts a lab space within Randolph Technical School, in the School District of Philadelphia, which has caused paint to peel and plaster to buckle around the window seal. Tr. 7812:1-23 (Hite). This condition has since been repaired at Randolph. Tr. 7813:4-6 (Hite).

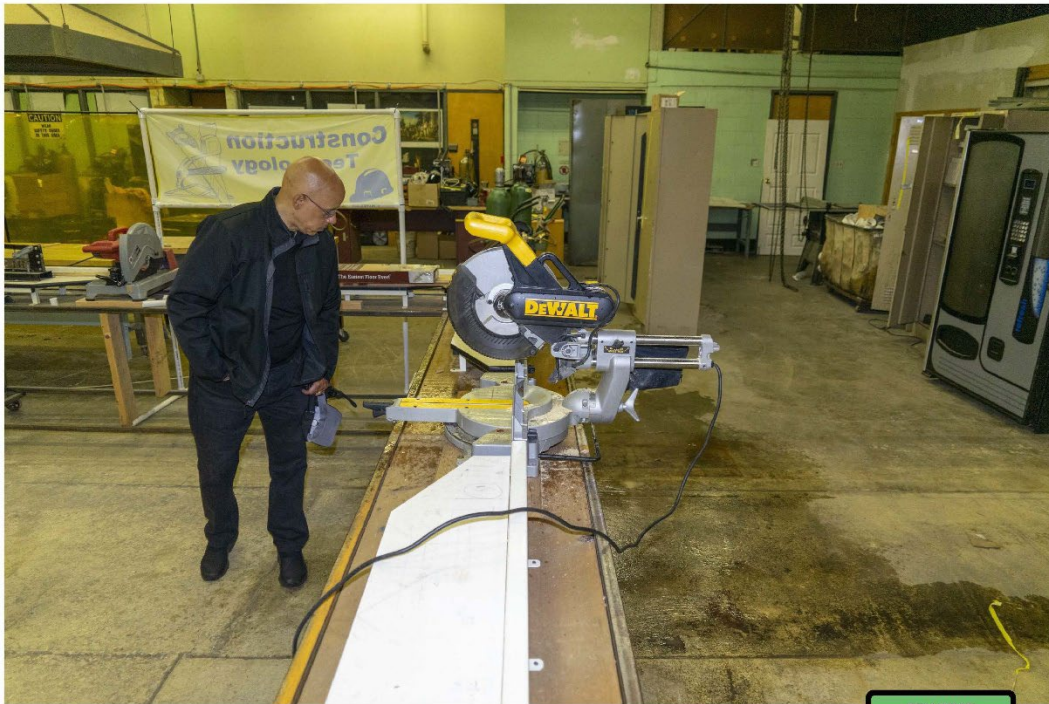
EXHIBIT  
**PX-00776**

**PX-776** depicts standing water on the floor of a lab space at Randolph Technical School in the School District of Philadelphia, where students commonly use electrical tools to practice carpentry or piping work. Tr. 7809:19-7810:16 (Hite). The flooding was caused by a leak in the roof that was over the lab space. Tr. 7810:11-16 (Hite). This flooding has rendered the space unusable due to the hazards of using electrical tools by leaks and standing water. Tr. 7810:21-7811:9 (Hite). The roof leak has been repaired at Randolph, but other schools in the district currently experience ongoing leaks. Tr. 7811:10-17 (Hite).

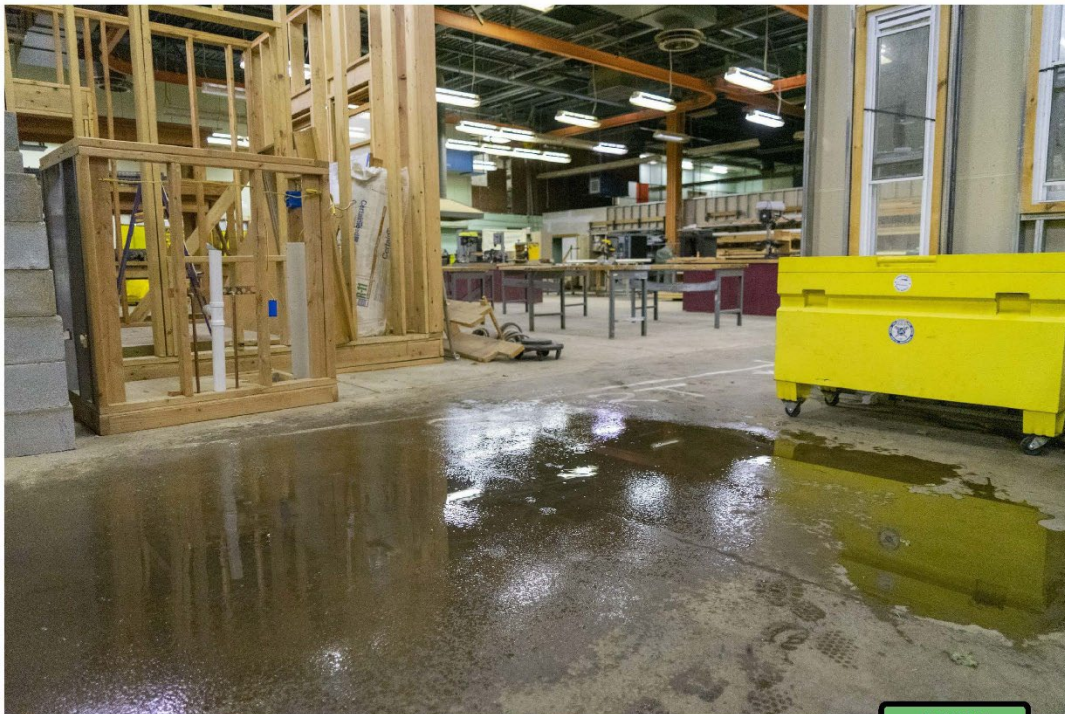
EXHIBIT  
**PX-00777**

**PX-777** depicts standing water on the floor of a lab space at Randolph Technical School, commonly used for student education in electrical work, plumbing, welding, and vendor machine repair. Tr. 7808:8-7809:18 (Hite). The flooding was caused by a leak in the roof that was over the lab space. Tr. 7808:14-7809:18 (Hite). The roof leak has been repaired at Randolph, but other schools in the School District of Philadelphia currently experience ongoing leaks. Tr. 7811:10-17 (Hite).
